# PROBLEM SUMMARY

Area  
**[05W35531]**  
 Machine Id  
**KAESER 7458329**  
 Component  
**Compressor**  
 Fluid  
**KAESER SIGMA (OEM) M-460 (--- GAL)**

# OIL ANALYSIS REPORT

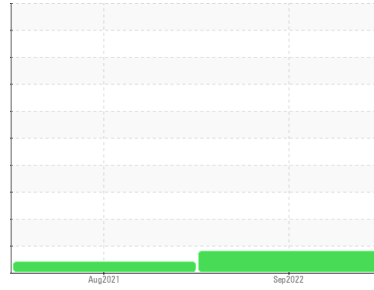
Sample Rating Trend

Sample Status			<b>ABNORMAL</b>	ABNORMAL	---
Particles >6µm	ASTM D7647	>1300	▲ <b>2955</b>	▲ 5997	---
Oil Cleanliness	ISO 4406 (c)	>--/17/13	▲ <b>20/19/13</b>	▲ 20/13	---

Oil and filter change at the time of sampling has been noted. Resample at the next service interval to monitor.

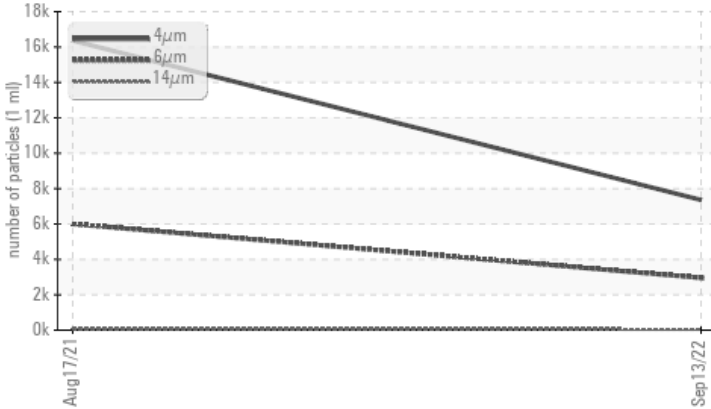
▲ Particle Trend

There is a high amount of silt (particulates < 14 microns in size) present in the oil.

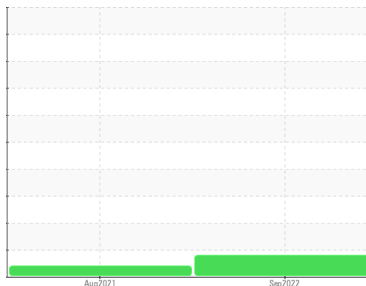
Sample Rating Trend

All component wear rates are normal.

The AN level is acceptable for this fluid. The condition of the oil is suitable for further service.

Oil and filter change at the time of sampling has been noted. Resample at the next service interval to monitor.

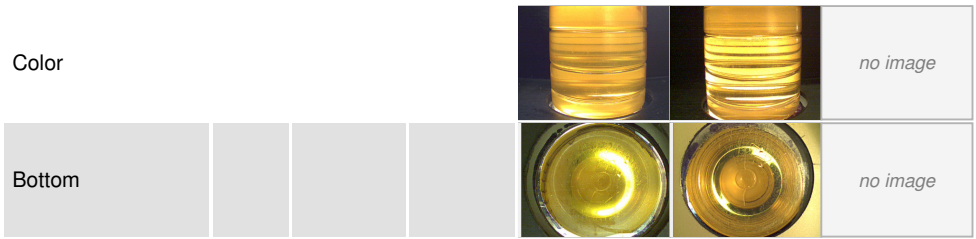
PARAMETER	method	limit/base	current	history1	history2
SAMPLE IMAGES

PARAMETER	VISUAL	method	limit/base	current	history1	history2
White Metal	scalar	*Visual	NONE	<b>NONE</b>	NONE	---
Yellow Metal	scalar	*Visual	NONE	<b>NONE</b>	NONE	---
Precipitate	scalar	*Visual	NONE	<b>NONE</b>	NONE	---
Silt	scalar	*Visual	NONE	<b>NONE</b>	NONE	---
Debris	scalar	*Visual	NONE	<b>NONE</b>	NONE	---
Sand/Dirt	scalar	*Visual	NONE	<b>NONE</b>	NONE	---
Appearance	scalar	*Visual	NORML	<b>NORML</b>	NORML	---
Odor	scalar	*Visual	NORML	<b>NORML</b>	NORML	---
Emulsified Water	scalar	*Visual	>0.05	<b>NEG</b>	NEG	---
Free Water	scalar	*Visual		<b>NEG</b>	NEG	---

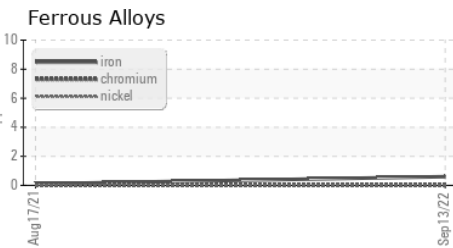
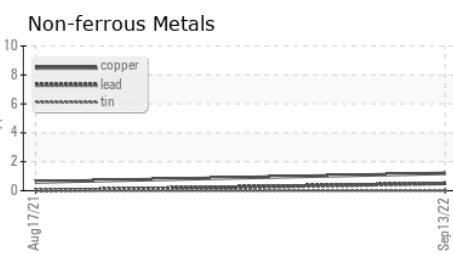
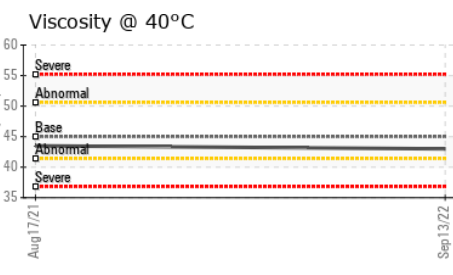
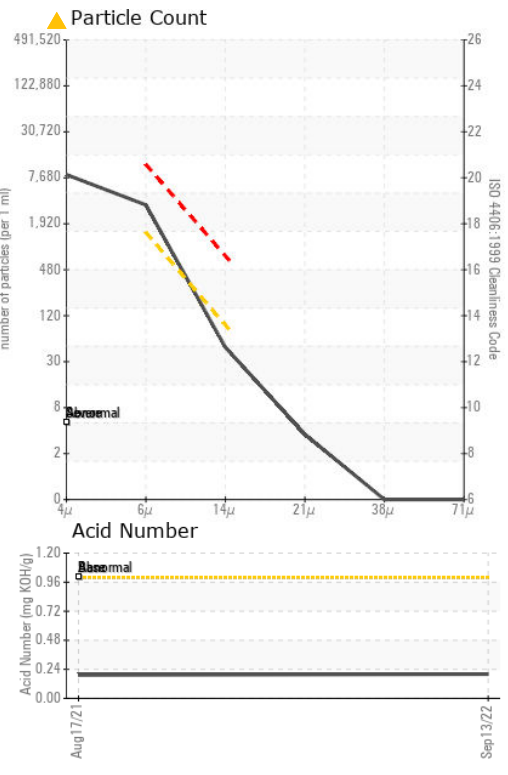
## GRAPHS

Oil and filter change at the time of sampling has been noted. Resample at the next service interval to monitor. All component wear rates are normal. There is a high amount of silt (particulates < 14 microns in size) present in the oil. The AN level is acceptable for this fluid. The condition of the oil is suitable for further service.
