# PROBLEM SUMMARY

Area  
**BARTO**  
 Machine Id  
**6330 [BARTO]**  
 Component  
**Diesel Engine**  
 Fluid  
**MOBIL DELVAC 1300 SUPER15W40 (--- GAL)**

# OIL ANALYSIS REPORT

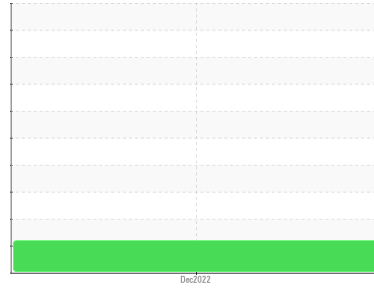
Sample Rating Trend

**FUEL**

▲ Fuel Dilution

▲ Viscosity @ 100°C

| Sample Status | | | | <b>ABNORMAL</b> | --- | --- |
|---|---|---|---|---|---|---|
| Fuel | % | ASTM D3524 | >5 | ▲ 3.2 | --- | --- |
| Visc @ 100°C | cSt | ASTM D445 | 14 | ▲ 11.9 | --- | --- |

We advise that you check the fuel injection system.  
 Resample at the next service interval to monitor.

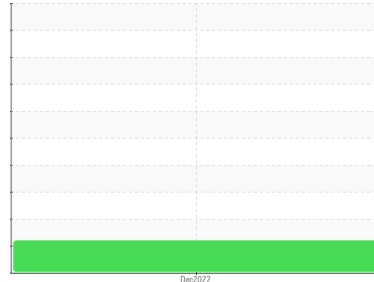
Sample Rating Trend

FUEL
