PROBLEM SUMMARY

Area
IRON STAR [200006142]
 Machine Id
G02-33WEA88332
 Component
Wind Turbine Gearbox
 Fluid
GEAR OIL (PAO) ISO 320 (--- LTR)

OIL ANALYSIS REPORT

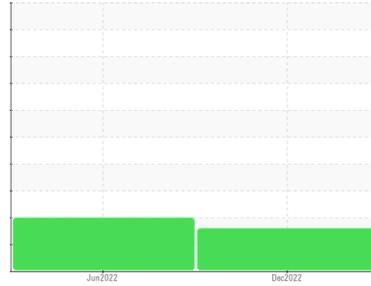
Sample Rating Trend

Sample Status			ABNORMAL	ABNORMAL	---
Particles >6µm	ASTM D7647	>320	▲ 1695	▲ 39723	---
Particles >14µm	ASTM D7647	>40	▲ 57	▲ 591	---
Particles >21µm	ASTM D7647	>10	▲ 13	▲ 139	---
Oil Cleanliness	ISO 4406 (c)	>--/15/12	▲ 22/18/13	▲ 24/22/16	---

We recommend you service the filters on this component if applicable. Resample at the next service interval to monitor.

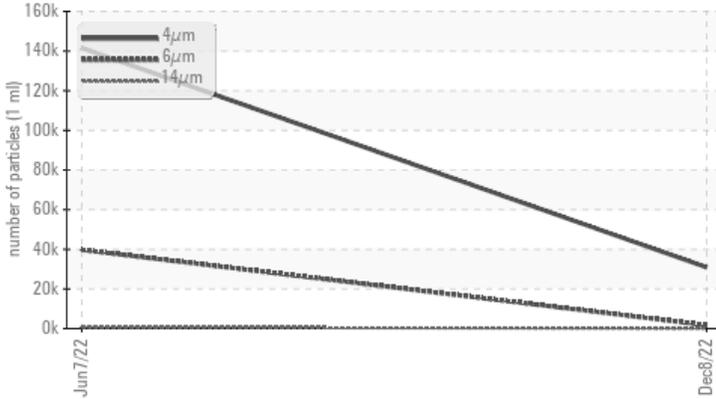
▲ Particle Trend

There is a high amount of particulates present in the oil.

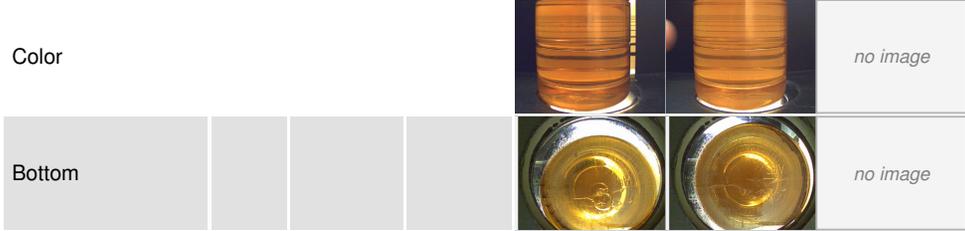
SAMPLE IMAGES	method	limit/base	current	history1	history2
---------------	--------	------------	---------	----------	----------

We recommend you service the filters on this component if applicable. Resample at the next service interval to monitor. All component wear rates are normal. There is a high amount of particulates present in the oil. The AN level is acceptable for this fluid. The condition of the oil is suitable for further service.
