Machine Id
KMGP UNIT 4

Component
Inboard Bearing

Fluid
ROYAL PURPLE SYNFILM GT 32 (--- GAL)

OIL ANALYSIS REPORT

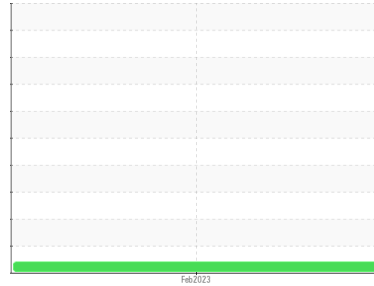
Sample Rating Trend

VIS DEBRIS

Sample Status				ABNORMAL	---	---
Debris	scalar	*Visual	NONE	▲ MODER	---	---

We recommend you service the filters on this component if applicable. Resample at the next service interval to monitor.

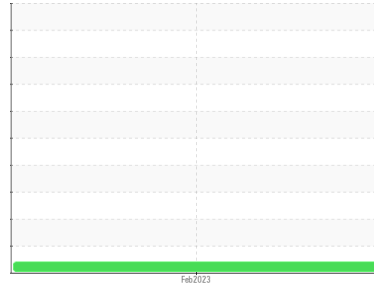
Sample Rating Trend

VIS DEBRIS

Moderate concentration of visible dirt/debris present in the oil.

We recommend you service the filters on this component if applicable. Resample at the next service interval to monitor.

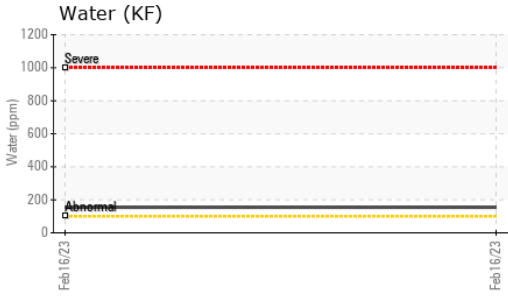
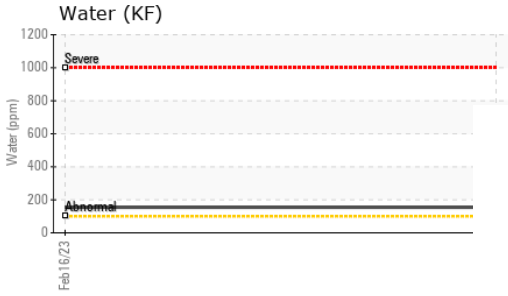
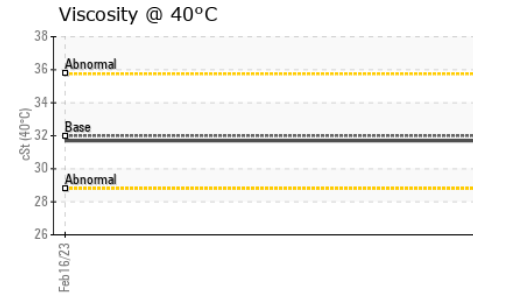
SAMPLE IMAGES	method	limit/base	current	history1	history2
Color				no image	no image
Bottom				no image	no image

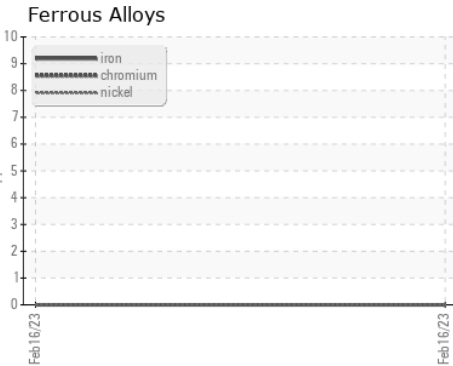
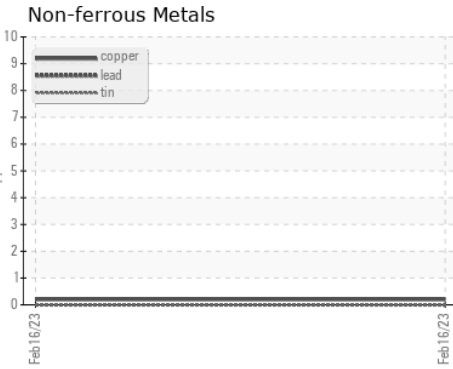
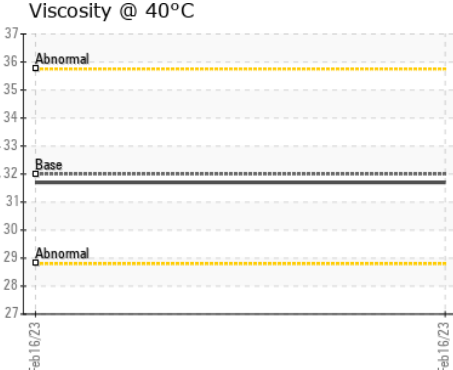
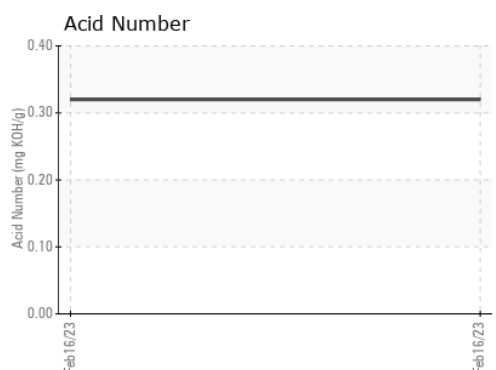
GRAPHS

All component wear rates are normal.

The AN level is acceptable for this fluid. The condition of the oil is acceptable for the time in service.
