OIL ANALYSIS REPORT

Machine Id
Boiler Feedwater Pump #2 (S/N M-152669)

Component
Drive End Bearing
Fluid
NOT GIVEN (2 GAL)

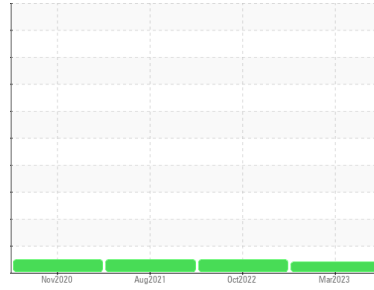
Sample Rating Trend

VIS DEBRIS

Sample Status				ABNORMAL	NORMAL	NORMAL
Debris	scalar	*Visual	NONE	▲ MODER	LIGHT	LIGHT

We suspect abnormal contamination may be due to sampling method. No corrective action is recommended at this time. Resample at the next service interval to monitor.

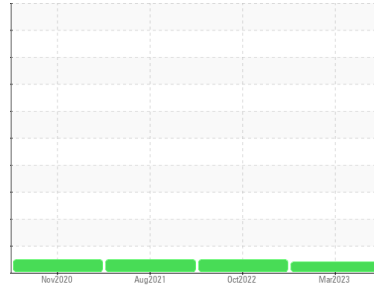
Sample Rating Trend

VIS DEBRIS

Moderate concentration of visible dirt/debris present in the oil.

We suspect abnormal contamination may be due to sampling method. No corrective action is recommended at this time. Resample at the next service interval to monitor.

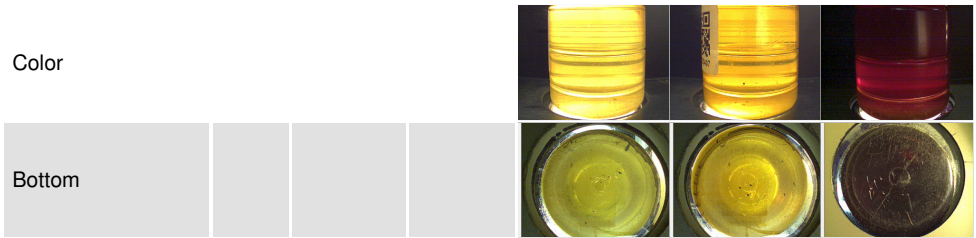
SAMPLE IMAGES	method	limit/base	current	history 1	history 2
---------------	--------	------------	---------	-----------	-----------

VISUAL		method	limit/base	current	history 1	history 2
White Metal	scalar	*Visual	NONE	NONE	NONE	NONE
Yellow Metal	scalar	*Visual	NONE	NONE	NONE	NONE
Precipitate	scalar	*Visual	NONE	NONE	NONE	NONE
Silt	scalar	*Visual	NONE	NONE	NONE	NONE
Debris	scalar	*Visual	NONE	▲ MODER	LIGHT	LIGHT
Sand/Dirt	scalar	*Visual	NONE	NONE	NONE	NONE
Appearance	scalar	*Visual	NORML	NORML	NORML	NORML
Odor	scalar	*Visual	NORML	NORML	NORML	NORML
Emulsified Water	scalar	*Visual	>2	NEG	NEG	NEG
Free Water	scalar	*Visual		NEG	omitted	omitted

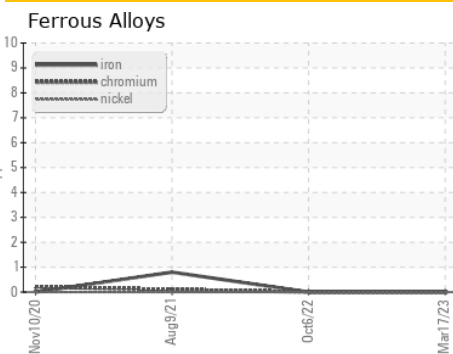
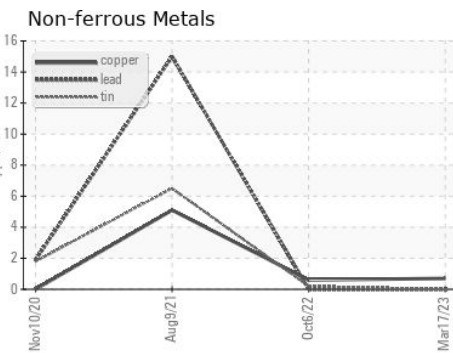
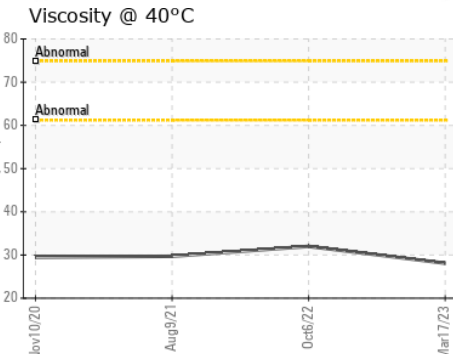
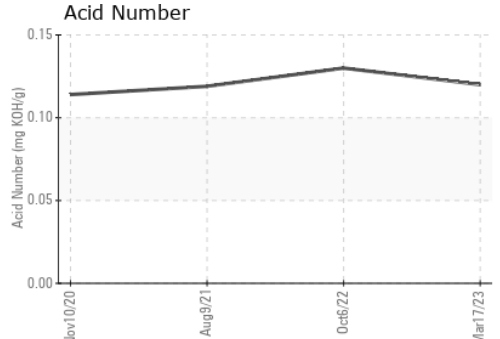
GRAPHS

WEAR METALS		method	limit/base	current	history 1	history 2
Iron	ppm	ASTM D5185m	>20	0	0	<1
Chromium	ppm	ASTM D5185m	>20	0	0	<1
Nickel	ppm	ASTM D5185m	>20	0	0	0
Titanium	ppm	ASTM D5185m		0	0	0
Silver	ppm	ASTM D5185m		0	0	0
Aluminum	ppm	ASTM D5185m	>20	0	0	0
Lead	ppm	ASTM D5185m	>20	0	0	15
Copper	ppm	ASTM D5185m	>20	<1	<1	5
Tin	ppm	ASTM D5185m	>20	0	<1	6
Antimony	ppm	ASTM D5185m		---	---	0
Vanadium	ppm	ASTM D5185m		0	0	0
Cadmium	ppm	ASTM D5185m		0	0	0

FLUID DEGRADATION		method	limit/base	current	history 1	history 2
Acid Number (AN)	mg KOH/g	ASTM D8045		0.12	0.13	0.119

FLUID PROPERTIES	method	limit/base	current	history 1	history 2
Visc @ 40°C	cSt	ASTM D445	28.1	32.0	29.7
