OIL ANALYSIS REPORT

Machine Id
1.1 FOX (S/N E000158)

Component
Rotary Compressor
Fluid
NOT GIVEN (--- GAL)

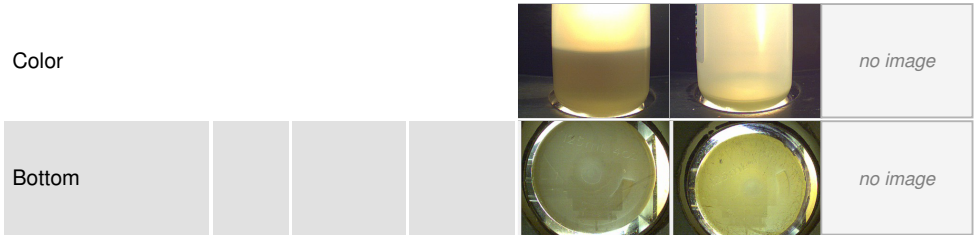
SAMPLE IMAGES	method	limit/base	current	history1	history2
---------------	--------	------------	---------	----------	----------

VISUAL	method	limit/base	current	history1	history2
White Metal	scalar	*Visual	NONE	NONE	---
Yellow Metal	scalar	*Visual	NONE	NONE	---
Precipitate	scalar	*Visual	NONE	NONE	---
Silt	scalar	*Visual	NONE	NONE	---
Debris	scalar	*Visual	NONE	NONE	LIGHT
Sand/Dirt	scalar	*Visual	NONE	NONE	---
Appearance	scalar	*Visual	NORML	NORML	---
Odor	scalar	*Visual	NORML	NORML	---
Emulsified Water	scalar	*Visual	>0.6	NEG	---
Free Water	scalar	*Visual		NEG	---
