Customer Id: ENEKAR
Sample No.: RP0027416
Lab Number: 05831292
Test Package: IND 2

OIL ANALYSIS REPORT

Machine Id
MLU-1
 Component
Outboard Lube System
 Fluid
ROYAL PURPLE SYNFILM GT 32 (--- GAL)

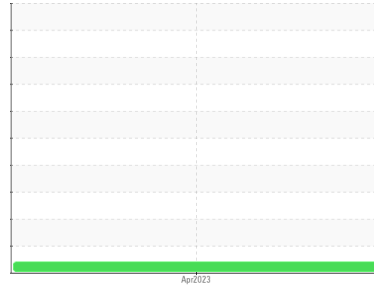
Sample Rating Trend

VIS DEBRIS

Sample Status				ABNORMAL	---	---
Debris	scalar	*Visual	NONE	▲ MODER	---	---

We suspect abnormal contamination may be due to sampling method. No corrective action is recommended at this time. Resample at the next service interval to monitor.

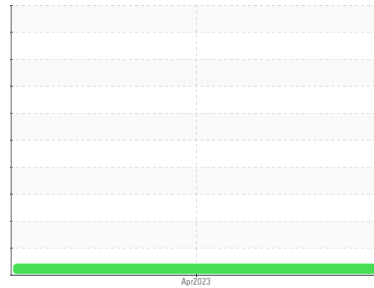
Sample Rating Trend

VIS DEBRIS

Moderate concentration of visible dirt/debris present in the oil.

We suspect abnormal contamination may be due to sampling method. No corrective action is recommended at this time. Resample at the next service interval to monitor.

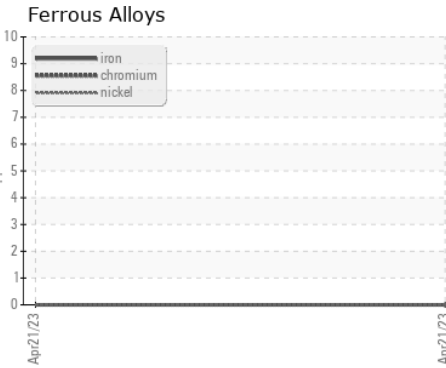
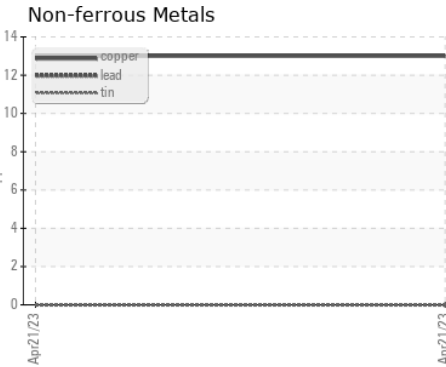
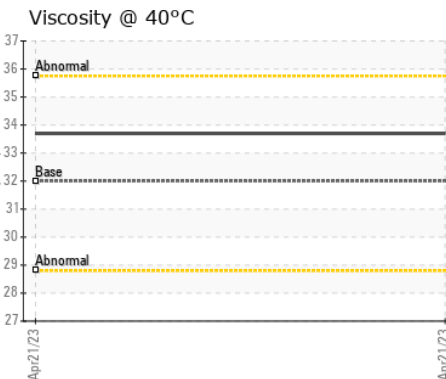
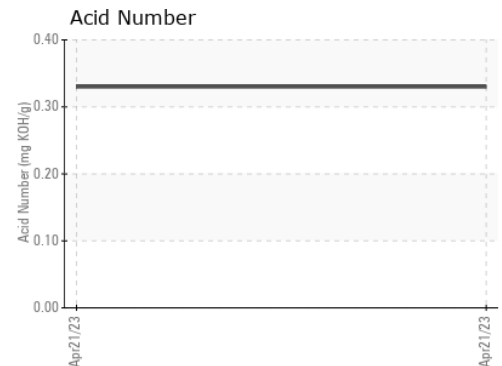
GRAPHS

All component wear rates are normal.

The AN level is acceptable for this fluid. The condition of the oil is suitable for further service.
