# OIL ANALYSIS REPORT

Machine Id  
**KAESER 5887817**

Component  
**Compressor**  
Fluid  
**KAESER SIGMA (OEM) M-460 (--- GAL)**

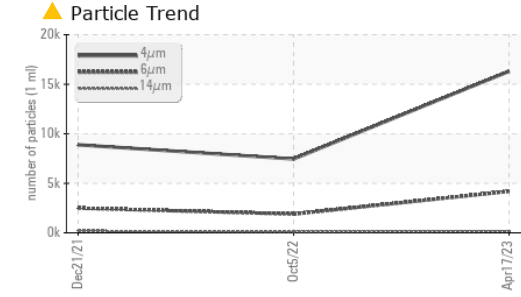
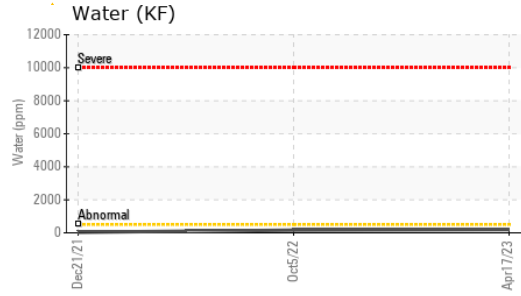
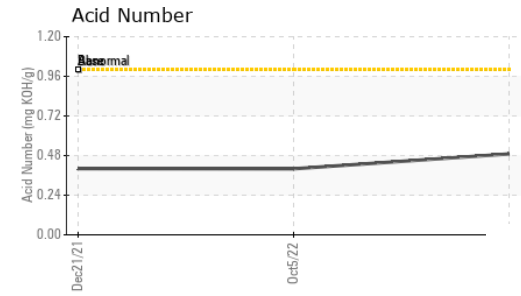
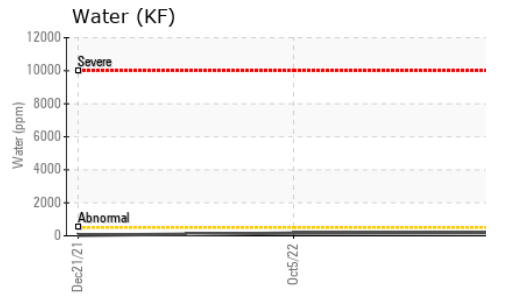
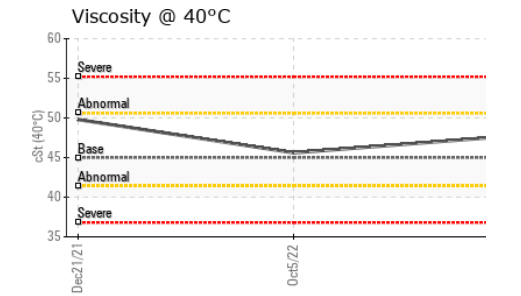
## GRAPHS

There is a high amount of particulates present in the oil.

FLUID CLEANLINESS		method	limit/base	current	history1	history2
Particles >4µm		ASTM D7647		<b>16308</b>	7453	8888
Particles >6µm		ASTM D7647	>1300	<b>▲ 4190</b>	▲ 1895	▲ 2492
Particles >14µm		ASTM D7647	>80	<b>▲ 174</b>	▲ 127	▲ 184
Particles >21µm		ASTM D7647	>20	<b>▲ 31</b>	▲ 31	▲ 38
Particles >38µm		ASTM D7647	>4	<b>2</b>	1	▲ 5
Particles >71µm		ASTM D7647	>3	<b>0</b>	0	0
Oil Cleanliness		ISO 4406 (c)	>--/17/13	<b>▲ 21/19/15</b>	▲ 20/18/14	▲ 18/15

Oil and filter change at the time of sampling has been noted. No corrective action is recommended at this time. Resample at the next service interval to monitor.

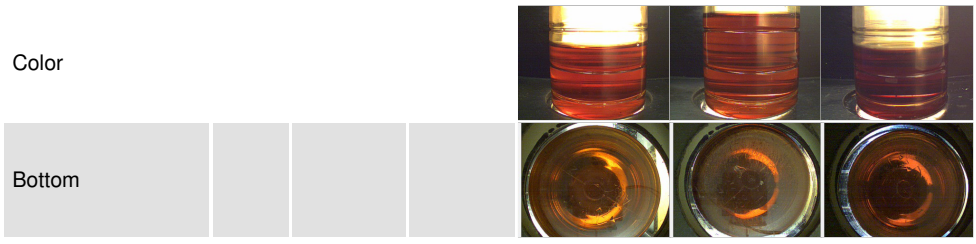
SAMPLE IMAGES	method	limit/base	current	history1	history2
---------------	--------	------------	---------	----------	----------

VISUAL	method	limit/base	current	history1	history2
White Metal	scalar	*Visual	NONE	NONE	NONE
Yellow Metal	scalar	*Visual	NONE	NONE	NONE
Precipitate	scalar	*Visual	NONE	NONE	NONE
Silt	scalar	*Visual	NONE	NONE	NONE
Debris	scalar	*Visual	NONE	NONE	NONE
Sand/Dirt	scalar	*Visual	NONE	NONE	NONE
Appearance	scalar	*Visual	NORML	NORML	NORML
Odor	scalar	*Visual	NORML	NORML	NORML
Emulsified Water	scalar	*Visual	>0.05	NEG	NEG
Free Water	scalar	*Visual		NEG	NEG
