# PROBLEM SUMMARY

Area  
**BATCH SYSTEM 7**  
Machine Id  
**BS7NA HOMO**  
Component  
**Hydraulic System**  
Fluid  
**HYDREX AW UNKNOWN (--- LTR)**

# OIL ANALYSIS REPORT

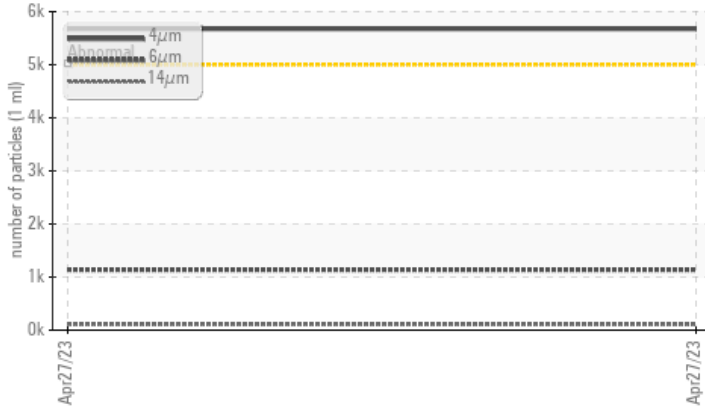
### ▲ Particle Trend

There is a moderate amount of silt (particulates < 6 microns in size) present in the oil.

method	limit/base	current	history1	history2
Particles >4µm ASTM D7647	>5000	<b>▲ 5675</b>	---	---
Particles >6µm ASTM D7647	>1300	<b>1138</b>	---	---
Particles >14µm ASTM D7647	>160	<b>108</b>	---	---
Particles >21µm ASTM D7647	>40	<b>23</b>	---	---
Particles >38µm ASTM D7647	>10	<b>2</b>	---	---
Particles >71µm ASTM D7647	>3	<b>0</b>	---	---
Oil Cleanliness ISO 4406 (c)	>19/17/14	<b>▲ 20/17/14</b>	---	---

Resample at the next service interval to monitor.
