OIL ANALYSIS REPORT

Machine Id
BFP-2A

Component
Pump

Fluid
ROYAL PURPLE SYNFILM GT 68 (--- GAL)

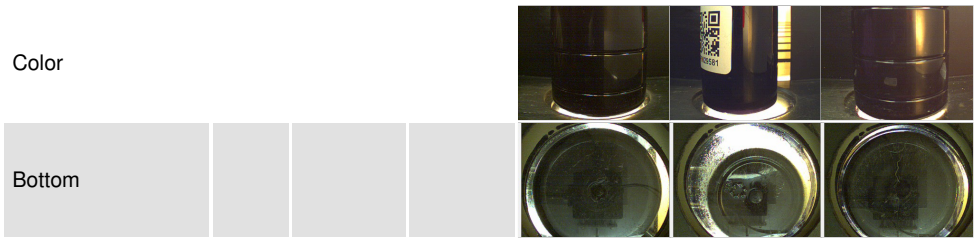
SAMPLE IMAGES	method	limit/base	current	history1	history2
---------------	--------	------------	---------	----------	----------

VISUAL	method	limit/base	current	history1	history2
White Metal	scalar	*Visual	NONE	NONE	NONE
Yellow Metal	scalar	*Visual	NONE	NONE	NONE
Precipitate	scalar	*Visual	NONE	NONE	NONE
Silt	scalar	*Visual	NONE	NONE	NONE
Debris	scalar	*Visual	NONE	NONE	NONE
Sand/Dirt	scalar	*Visual	NONE	NONE	NONE
Appearance	scalar	*Visual	NORML	NORML	NORML
Odor	scalar	*Visual	NORML	NORML	NORML
Emulsified Water	scalar	*Visual	NEG	NEG	NEG
Free Water	scalar	*Visual	NEG	NEG	NEG

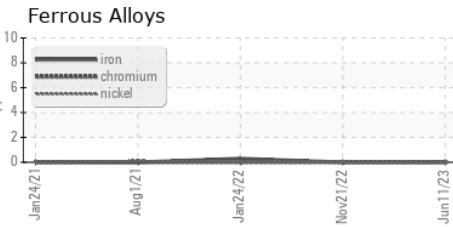
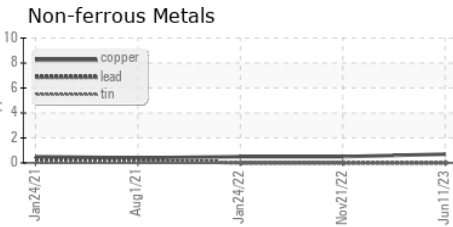
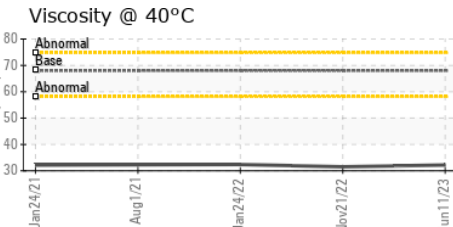
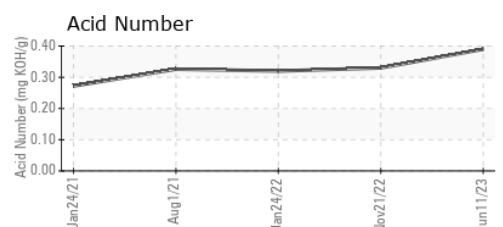
GRAPHS

All component wear rates are normal.

There is no indication of any contamination in the oil.

The AN level is acceptable for this fluid. The condition of the oil is suitable for further service.

Resample at the next service interval to monitor.
