OIL ANALYSIS REPORT

Area
CONNECTION BAY CRANES
 Machine Id
CB 20.2 SOUTHEAST BRIDGE
 Component
Gearbox
 Fluid
GEAR OIL ISO 220 (--- QTS)

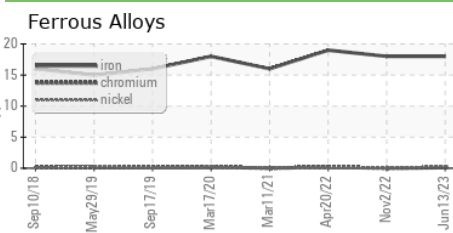
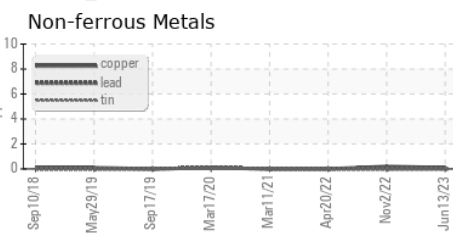
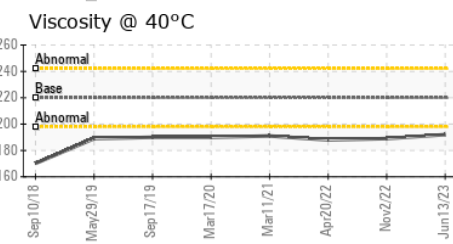
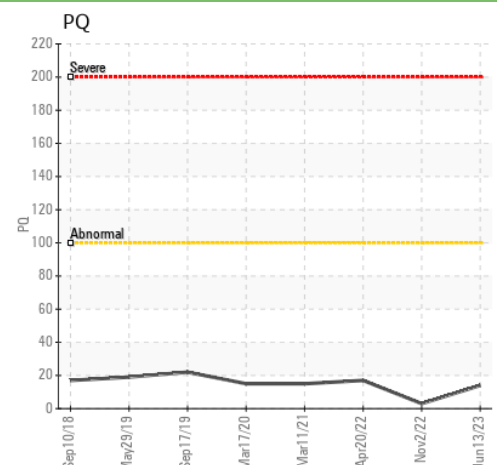
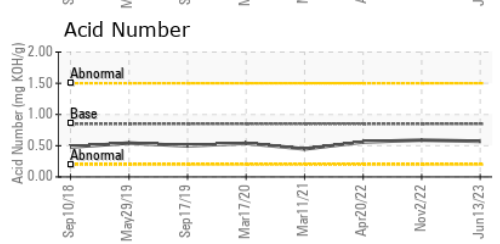
GRAPHS

All component wear rates are normal.

There is no indication of any contamination in the oil.

The AN level is acceptable for this fluid. The condition of the oil is suitable for further service.

Resample at the next service interval to monitor.
