Area  
**INDIANA CROSSROADS II [46004111]**  
 Machine Id  
**T14 (S/N W-124771)**  
 Component  
**New (Unused) Oil**  
 Fluid  
**FUCHS RENOLIN CLP ISO 320 (--- LTR)**

Customer Id: NORDEX  
 Sample No.: NX013301  
 Lab Number: 05878510  
 Test Package: IND 2

# OIL ANALYSIS REPORT

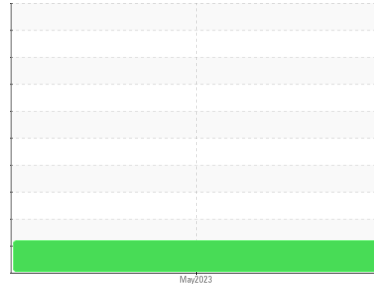
### ▲ Particle Trend

Sample Status			<b>ABNORMAL</b>	---	---
Particles >4µm	ASTM D7647	>5000	▲ <b>18282</b>	---	---
Particles >6µm	ASTM D7647	>1300	▲ <b>3038</b>	---	---
Oil Cleanliness	ISO 4406 (c)	>19/17/14	▲ <b>21/19/14</b>	---	---

This is a baseline read-out on the submitted sample.

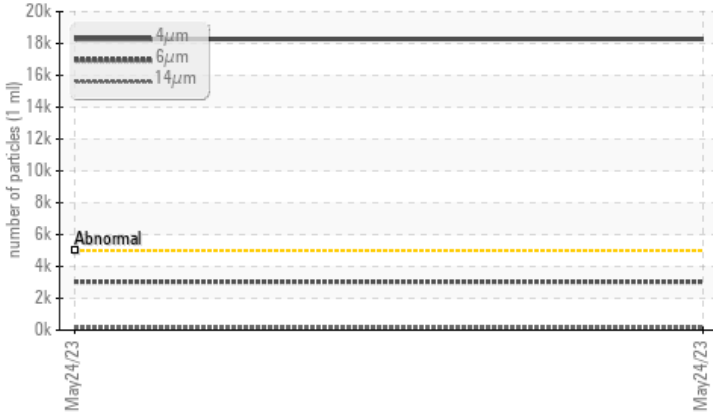
There is a high amount of silt (particulates < 14 microns in size) present in the oil.
