Laboratory : WearCheck USA - 501 Madison Ave., Cary, NC 27513
Sample No. : WC0825618 **Received** : 22 Jun 2023
Lab Number : 05880935 **Diagnosed** : 30 Jun 2023
Unique Number : 10526038 **Diagnostician** : Jonathan Hester
Test Package : PLANT (Additional Tests: KV100, VI)

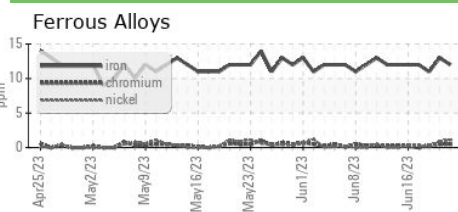
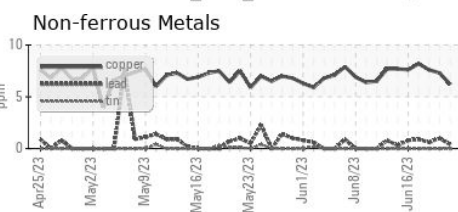
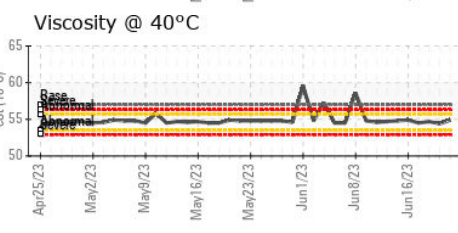
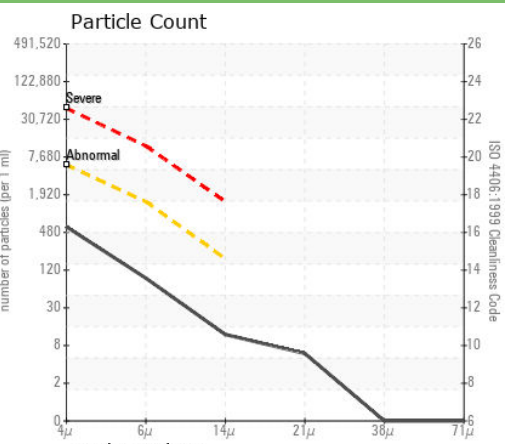
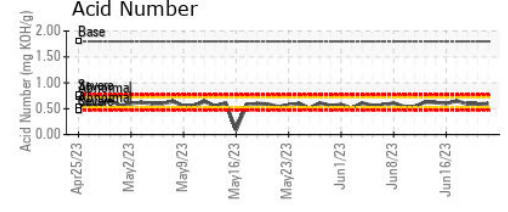
GRAPHS

FLUID PROPERTIES	method	limit/base	current	history 1	history 2
Visc @ 40°C	cSt	ASTM D445	57.0	54.4	54.7
Visc @ 100°C	cSt	ASTM D445	9.4	9.3	9.58
Viscosity Index (VI)	Scale	ASTM D2270	147	153	160
