OIL ANALYSIS REPORT

Area
97
 Machine Id
[97] A97 A124
 Component
Center Agitator Gearbox
 Fluid
Gear Life 220 (6 GAL)

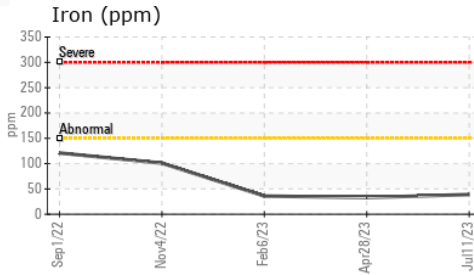
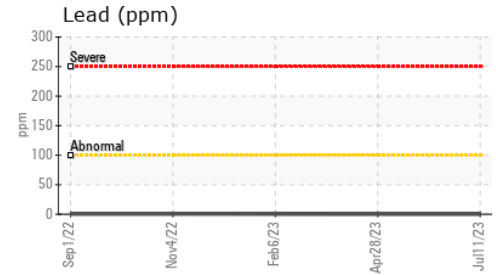
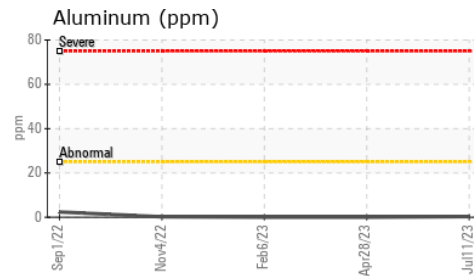
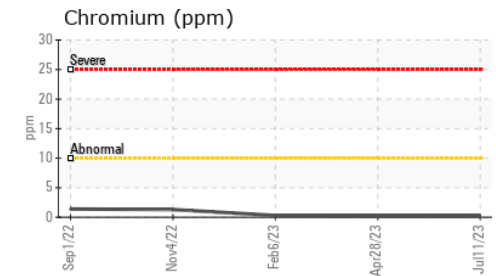
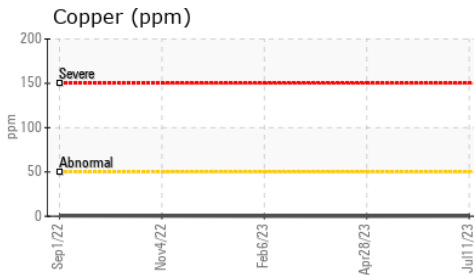
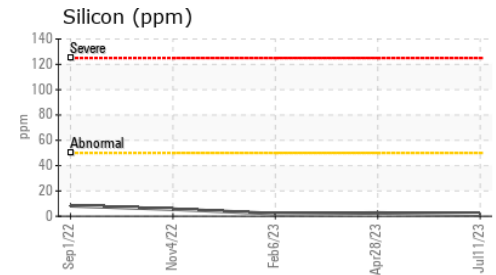
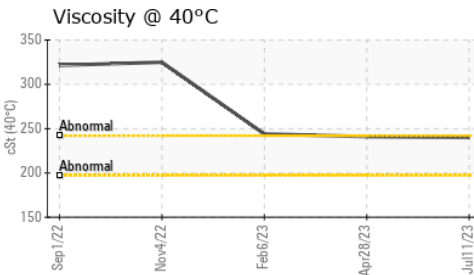
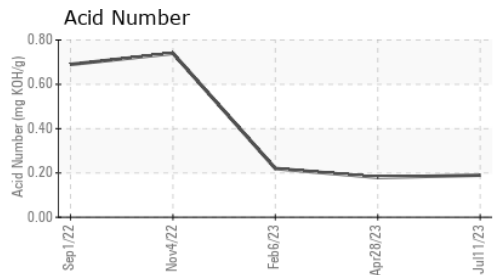
GRAPHS

All component wear rates are normal.

There is no indication of any contamination in the oil.

The AN level is acceptable for this fluid. The condition of the oil is suitable for further service.

Resample at the next service interval to monitor.
