Customer Id: HILDAL
Sample No.: USP255409
Lab Number: 05901303
Test Package: IND 2

OIL ANALYSIS REPORT

Area
[40998313]
 Machine Id
DVT 6 (S/N 2600849)
 Component
Hydraulic System
 Fluid
NOT GIVEN (--- GAL)

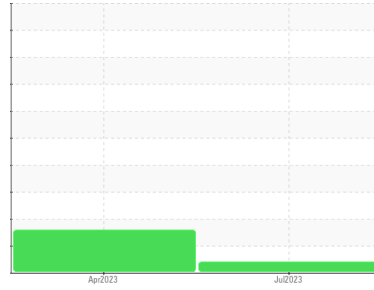
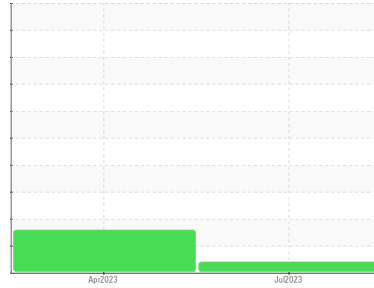
Sample Rating Trend

VIS DEBRIS

Moderate concentration of visible dirt/debris present in the oil.

We recommend you service the filters on this component. Resample at the next service interval to monitor. We were unable to perform a particle count due to a high concentration of particles present in this sample.

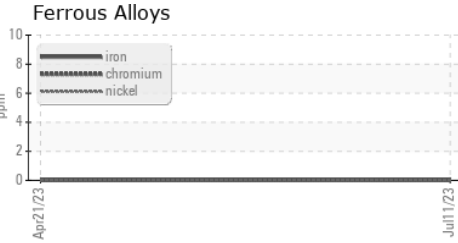
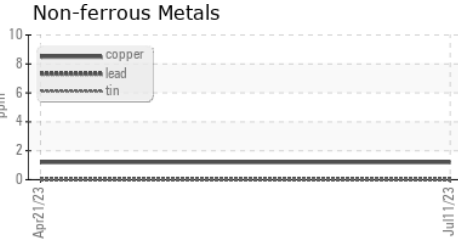
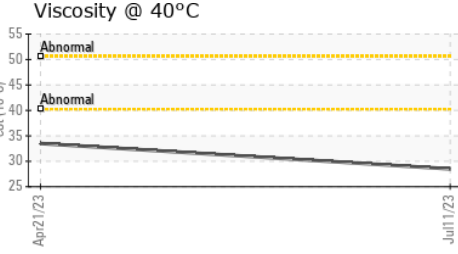
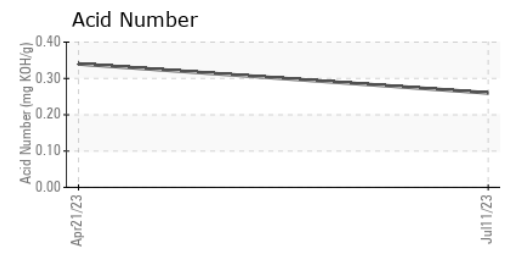
GRAPHS

Resample at the next service interval to monitor. All component wear rates are normal. There is a high amount of silt (particulates < 14 microns in size) present in the oil. The oil viscosity is higher than normal. Confirmed. The AN level is acceptable for this fluid.

FLUID PROPERTIES	method	limit/base	current	history1	history2
Visc @ 40°C	cSt	ASTM D445	28.5	▲ 33.5	---

We recommend you service the filters on this component. Resample at the next service interval to monitor. We were unable to perform a particle count due to a high concentration of particles present in this sample.
