# PROBLEM SUMMARY

Area  
**[603954402 SDR]**  
 Machine Id  
**COLD WATER PUMP 3 (S/N 20064006)**  
 Component  
**Primary Pump**  
 Fluid  
**ISO 68 (--- GAL)**

# OIL ANALYSIS REPORT

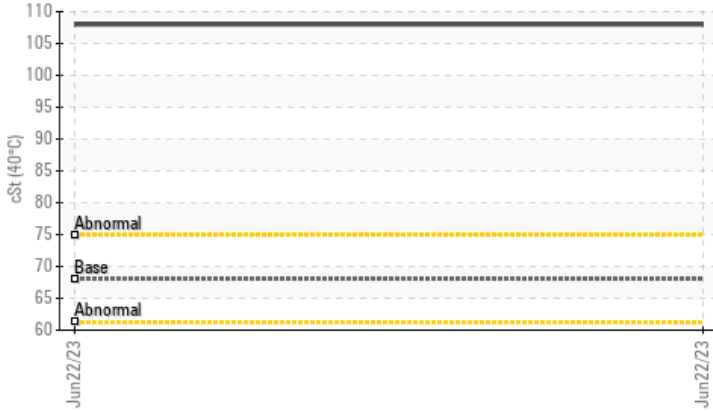
▲ Viscosity @ 40°C

Sample Status				<b>ATTENTION</b>	---	---
Visc @ 40°C	cSt	ASTM D445	68.0	▲ 108	---	---

Resample at the next service interval to monitor.
