Area
PALEXTRA 44
Machine Id
PALATEK 1810180003 - TEAM INDUSTRIES
Component
Compressor

OIL ANALYSIS REPORT

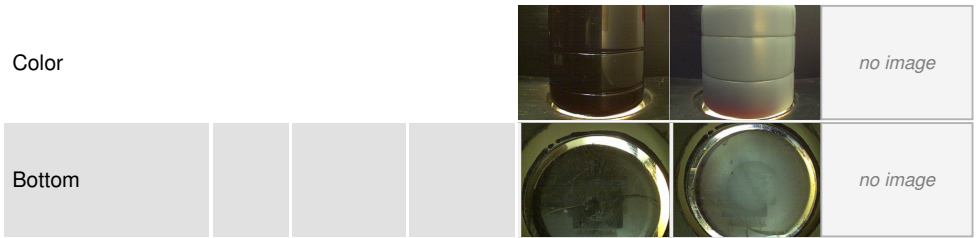
| SAMPLE IMAGES | method | limit/base | current | history1 | history2 |

| VISUAL | | method | limit/base | current | history1 | history2 |
|---|---|---|---|---|---|---|
| Appearance | scalar | *Visual | NORML | NORML | NORML | --- |
| Odor | scalar | *Visual | NORML | NORML | NORML | --- |

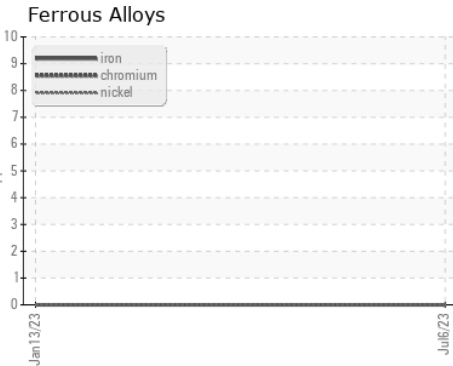
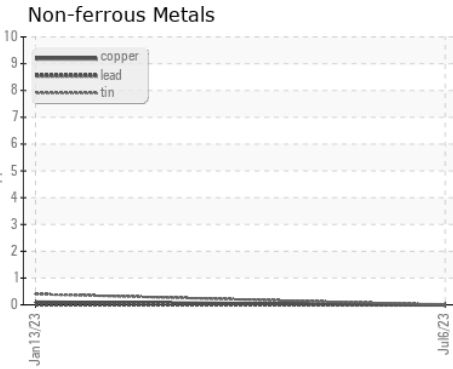
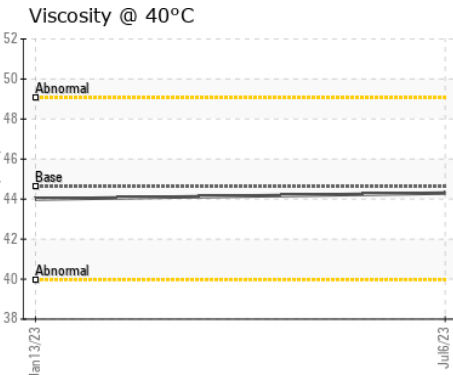
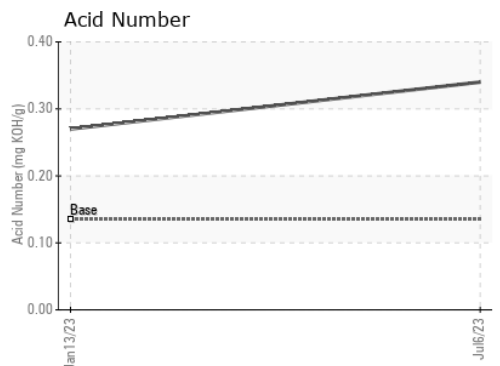
GRAPHS

All component wear rates are normal.

There is no indication of any contamination in the oil.

The AN level is acceptable for this fluid. The condition of the oil is suitable for further service.

Resample at the next service interval to monitor.
