Machine Id
6135593 (S/N 1034)

OIL ANALYSIS REPORT

Component
Compressor
Fluid
KAESER SIGMA (OEM) S-460 (--- GAL)

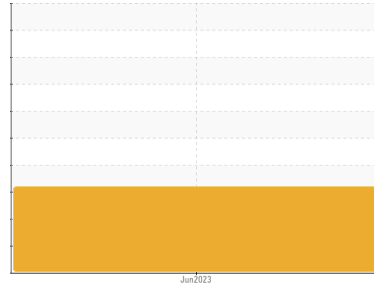
Sample Rating Trend

WATER

▲ Water

Sample Status				ABNORMAL	---	---
Water	%	ASTM D6304	>0.05	▲ 0.207	---	---
ppm Water	ppm	ASTM D6304	>500	▲ 2070	---	---
Emulsified Water	scalar	*Visual	>0.05	▲ 0.2%	---	---
Free Water	scalar	*Visual		▲ 20.0	---	---

Oil and filter change at the time of sampling has been noted. There is too much water present in this sample to perform a particle count. We recommend an early resample in 500 hours to monitor this condition.

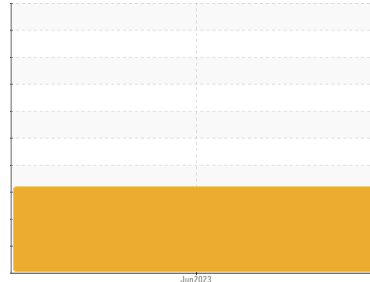
Sample Rating Trend

WATER

There is a moderate concentration of water present in the oil. Excessive free water present.

Oil and filter change at the time of sampling has been noted. There is too much water present in this sample to perform a particle count. We recommend an early resample in 500 hours to monitor this condition.

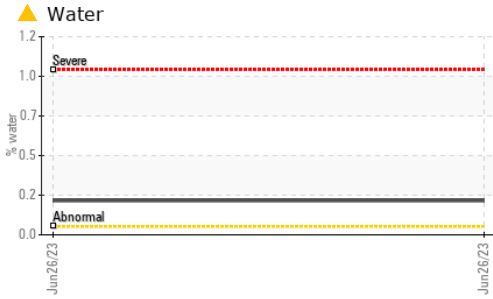
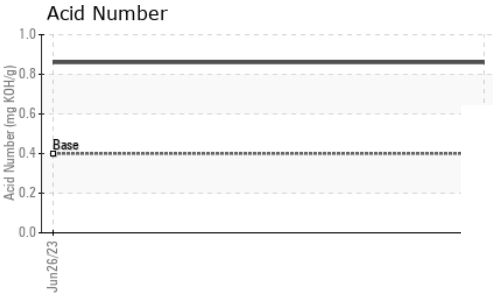
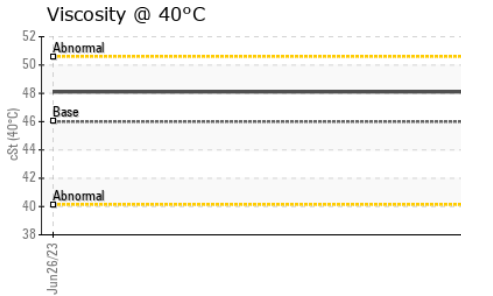
method	limit/base	current	history1	history2
Silicon	ppm ASTM D5185m >25	0	---	---
Sodium	ppm ASTM D5185m	<1	---	---
Potassium	ppm ASTM D5185m >20	0	---	---
Water	% ASTM D6304 >0.05	▲ 0.207	---	---
ppm Water	ppm ASTM D6304 >500	▲ 2070	---	---
