OIL ANALYSIS REPORT

Area
KANSAS/44/EG - OTHER SERVICE
 Machine Id
74.21L [KANSAS^44^EG - OTHER SERVICE]
 Component
Front Right Final Drive
 Fluid
MOBIL MOBILUBE HD PLUS 85W140 (--- GAL)

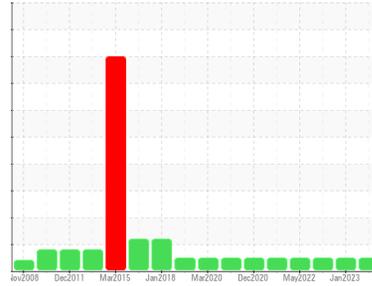
Sample Rating Trend

NORMAL

All component wear rates are normal.

There is no indication of any contamination in the oil.

Confirm oil type. The condition of the oil is acceptable for the time in service.

Resample at the next service interval to monitor. (Customer Sample Comment: 14216 hrs)
