PROBLEM SUMMARY

OIL ANALYSIS REPORT

Area
LOHT
 Machine Id
[LOHT] LOHT-P-G0047B GRBX,ON CHR G PMP (B)
 Component
Gearbox
 Fluid
ROYAL PURPLE SYNFILM GT220 (--- QTS)

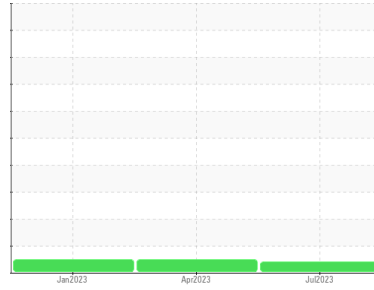
Sample Rating Trend

VIS DEBRIS

Sample Status		ABNORMAL	NORMAL	NORMAL
Debris	scalar *Visual	▲ MODER	NONE	NONE

Resample at the next service interval to monitor.

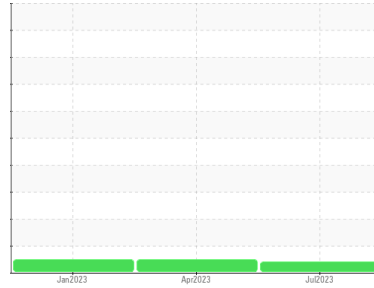
Sample Rating Trend

VIS DEBRIS

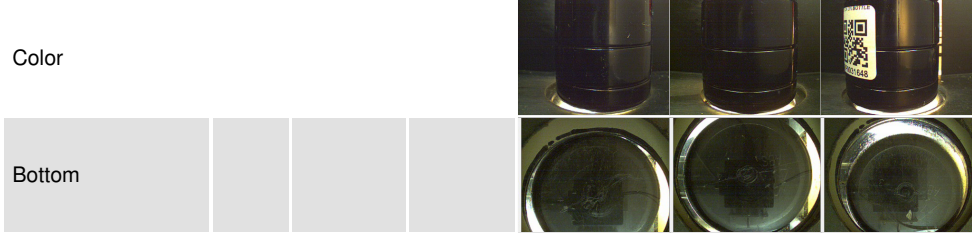
SAMPLE IMAGES	method	limit/base	current	history1	history2
---------------	--------	------------	---------	----------	----------

Contamination
 Moderate concentration of visible dirt/debris present in the oil.

Recommendation
 Resample at the next service interval to monitor.
