# OIL ANALYSIS REPORT

Area  
**CHEVRON [1382726]**  
 Machine Id  
**ATLAS COPCO APF167-166**  
 Component  
**Compressor**

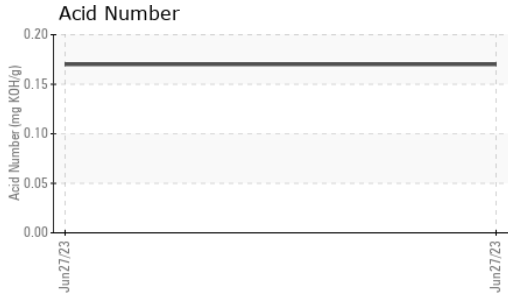
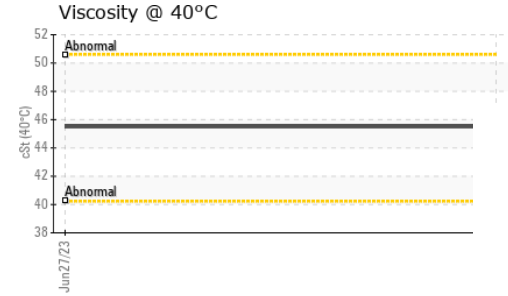
FLUID PROPERTIES	method	limit/base	current	history1	history2
Visc @ 40°C	cSt	ASTM D445	45.5	---	---

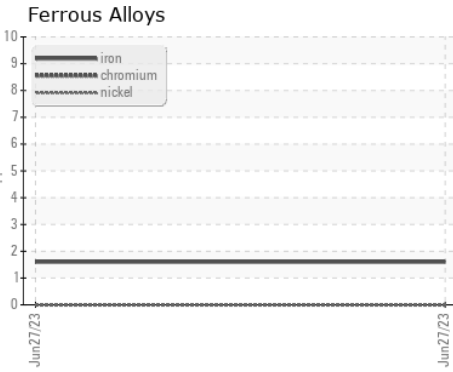
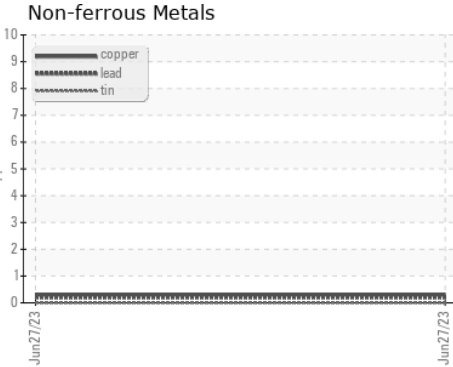
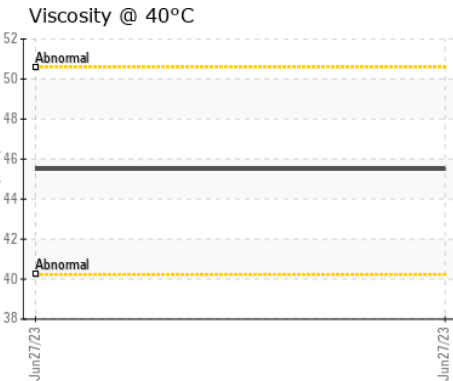
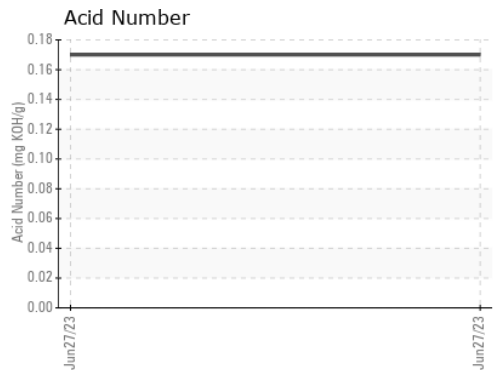
## GRAPHS

Moderate concentration of visible metal present. All component wear rates are normal.

Moderate concentration of visible dirt/debris present in the oil.

The AN level is acceptable for this fluid. The condition of the oil is suitable for further service.

We suspect abnormal contamination may be due to sampling method. We recommend you service the filters on this component if applicable. Resample at the next service interval to monitor.
