# OIL ANALYSIS REPORT

Area  
**KANSAS/44**  
 Machine Id  
**38.87 [KANSAS^44]**  
 Component  
**Rear Left Final Drive**  
 Fluid  
**MOBIL MOBILTRANS HD 50 (--- GAL)**

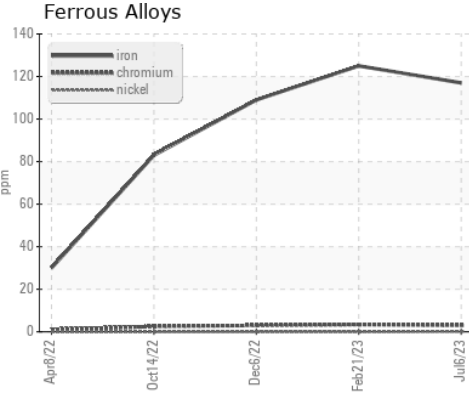
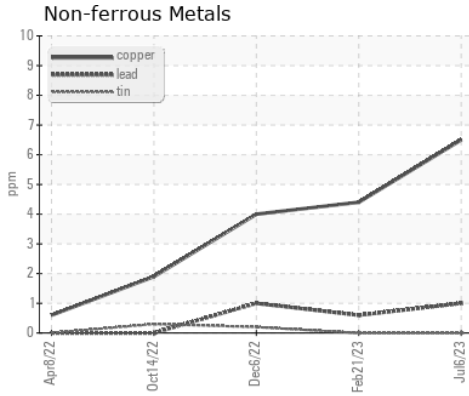
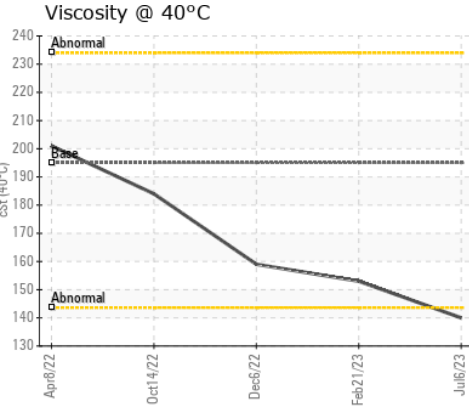
## GRAPHS

All component wear rates are normal.

There is no indication of any contamination in the oil.

The condition of the oil is acceptable for the time in service.

Resample at the next service interval to monitor.
