OIL ANALYSIS REPORT

Area
Bernardsville
 Machine Id
ISUZU 3435

Component
Diesel Engine
 Fluid
GIBRALTAR 15W/40 SUPER S-3 LX (11)

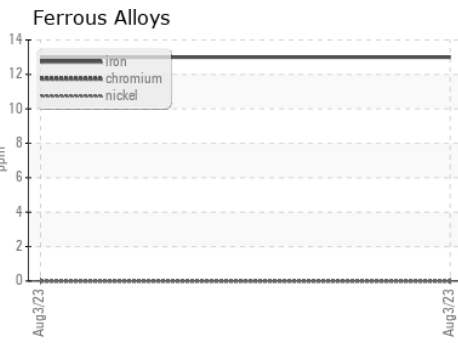
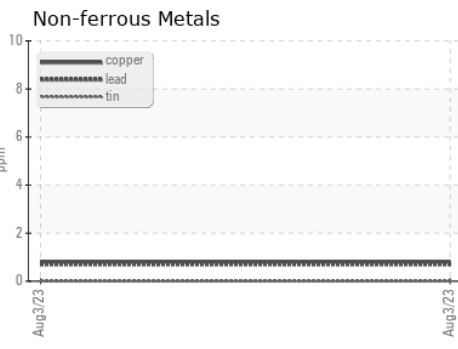
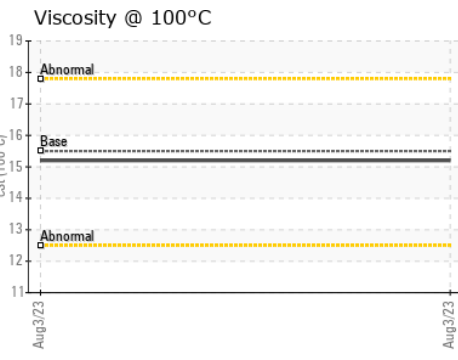
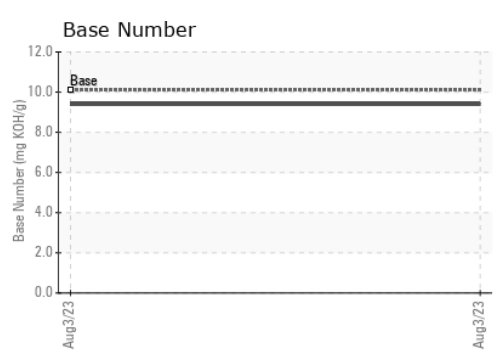
GRAPHS

All component wear rates are normal.

There is no indication of any contamination in the oil.

The BN result indicates that there is suitable alkalinity remaining in the oil. The condition of the oil is suitable for further service.

Resample at the next service interval to monitor.
