OIL ANALYSIS REPORT

Machine Id
TRANE 400 N CAPITAL C2 (S/N L94B01156)

Component
Refrigeration Compressor
Fluid
TRANE 0022 (8 GAL)

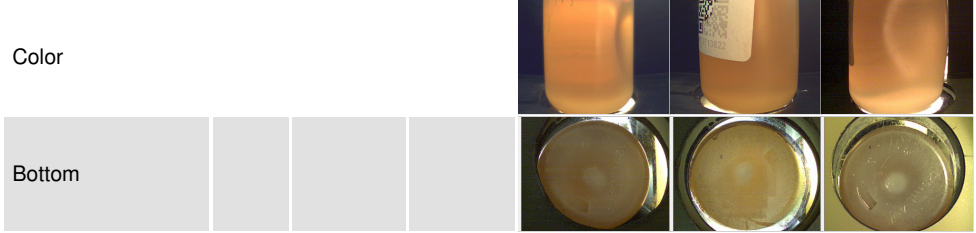
SAMPLE IMAGES	method	limit/base	current	history1	history2
---------------	--------	------------	---------	----------	----------

VISUAL	method	limit/base	current	history1	history2
White Metal	scalar	*Visual	NONE	NONE	NONE
Yellow Metal	scalar	*Visual	NONE	NONE	NONE
Precipitate	scalar	*Visual	NONE	NONE	NONE
Silt	scalar	*Visual	NONE	NONE	NONE
Debris	scalar	*Visual	NONE	NONE	NONE
Sand/Dirt	scalar	*Visual	NONE	NONE	NONE
Appearance	scalar	*Visual	NORML	NORML	NORML
Odor	scalar	*Visual	NORML	NORML	NORML
Emulsified Water	scalar	*Visual	>0.01	NEG	NEG
Free Water	scalar	*Visual		NEG	NEG
