# PROBLEM SUMMARY

Machine Id  
**KENWORTH 775**

Component  
**Diesel Engine**

# OIL ANALYSIS REPORT

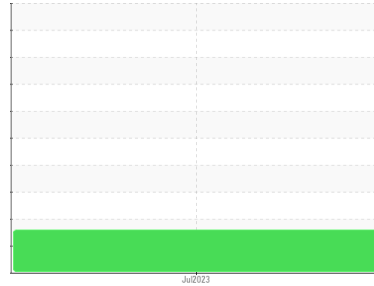
Sample Rating Trend

Sample Status	ABNORMAL		---	---
Silicon	ppm	ASTM D5185m >25	▲ 29	---

No corrective action is recommended at this time. Oil and filter change at the time of sampling has been noted. Resample at the next service interval to monitor.

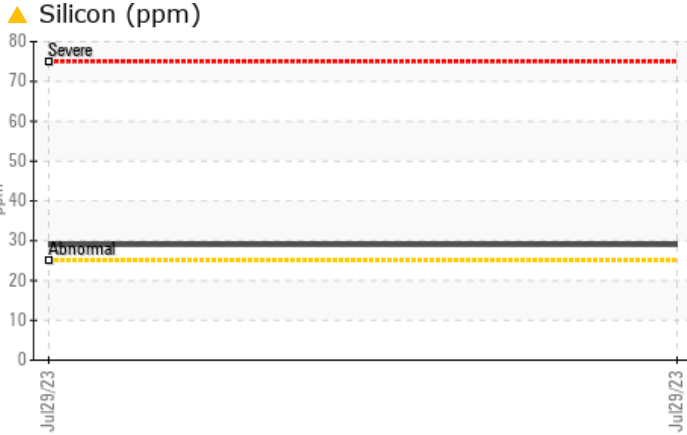
## COMPONENT CONDITION SUMMARY

Elemental level of silicon (Si) above normal indicating ingress of seal material.

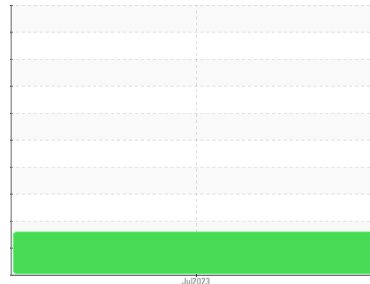
Sample Rating Trend

All component wear rates are normal.

The BN result indicates that there is suitable alkalinity remaining in the oil. The condition of the oil is suitable for further service.

No corrective action is recommended at this time. Oil and filter change at the time of sampling has been noted. Resample at the next service interval to monitor.
