Customer Id: ENEJEW
 Sample No.: RP0021871
 Lab Number: 05924381
 Test Package: IND 2

OIL ANALYSIS REPORT

Machine Id
HPDL_B3120 HPDL_B3120_P3120
 Component
Drive End Pump
 Fluid
ROYAL PURPLE SYNFILM GT 46 (1 QTS)

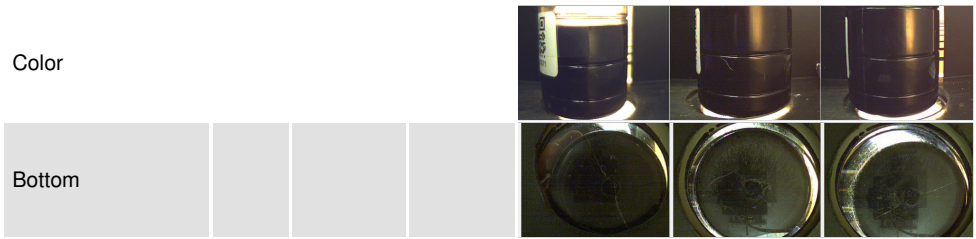
SAMPLE IMAGES	method	limit/base	current	history1	history2
---------------	--------	------------	---------	----------	----------

Moderate concentration of visible dirt/debris present in the oil.

VISUAL	method	limit/base	current	history1	history2
White Metal	scalar	*Visual	NONE	NONE	NONE
Yellow Metal	scalar	*Visual	NONE	NONE	NONE
Precipitate	scalar	*Visual	NONE	NONE	NONE
Silt	scalar	*Visual	NONE	NONE	NONE
Debris	scalar	*Visual	▲ MODER	NONE	LIGHT
Sand/Dirt	scalar	*Visual	NONE	NONE	NONE
Appearance	scalar	*Visual	NORML	NORML	NORML
Odor	scalar	*Visual	NORML	NORML	NORML
Emulsified Water	scalar	*Visual	NEG	NEG	NEG
Free Water	scalar	*Visual	NEG	NEG	NEG

We recommend you service the filters on this component if applicable. Resample at the next service interval to monitor.
