Machine Id
KAESER 8670318 - YENFENG (S/N 2034)
 Component
Compressor
 Fluid
KAESER SIGMA (OEM) S-460 (--- GAL)

Customer Id: PALFOU
Sample No.: WC0795199
Lab Number: 05925494
Test Package: IND 2

OIL ANALYSIS REPORT

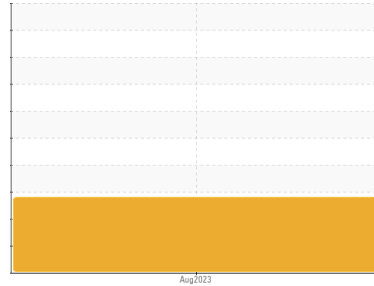
Sample Rating Trend

WATER

Sample Status				ABNORMAL	---	---
Water	%	ASTM D6304	>0.05	▲ 0.222	---	---
ppm Water	ppm	ASTM D6304	>500	▲ 2220	---	---
Silt	scalar	*Visual	NONE	▲ MODER	---	---
Debris	scalar	*Visual	NONE	▲ MODER	---	---
Emulsified Water	scalar	*Visual	>0.05	▲ 0.2%	---	---

No corrective action is recommended at this time. The filter change at the time of sampling has been noted. Resample at the next service interval to monitor.

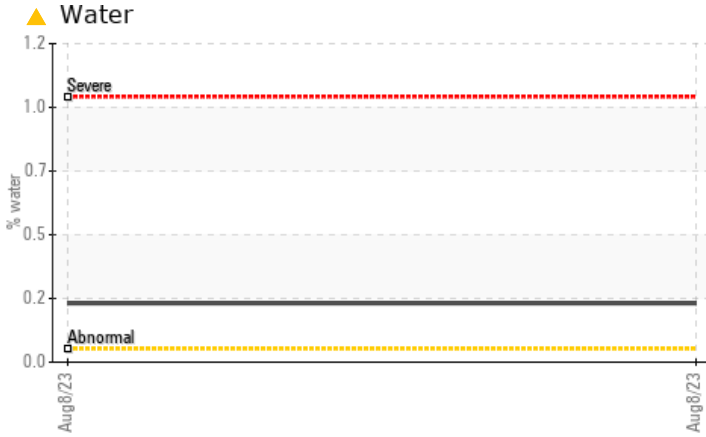
COMPONENT CONDITION SUMMARY

Moderate concentration of visible dirt/debris present in the oil. There is a light concentration of water present in the oil. There is a moderate amount of visible silt present in the sample.

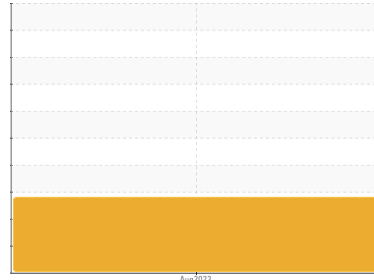
Sample Rating Trend

WATER

No corrective action is recommended at this time. The filter change at the time of sampling has been noted. Resample at the next service interval to monitor.

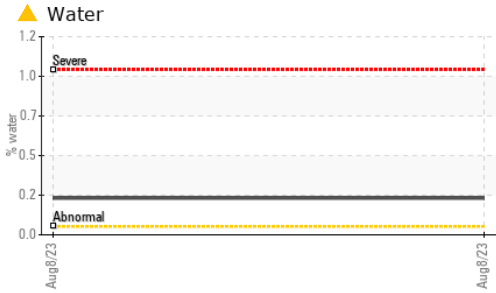
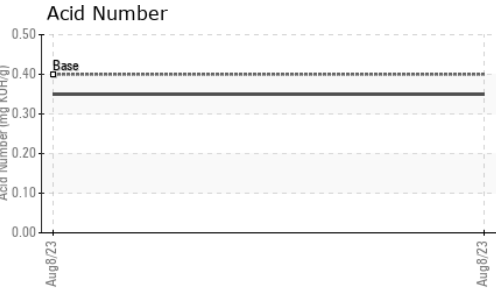
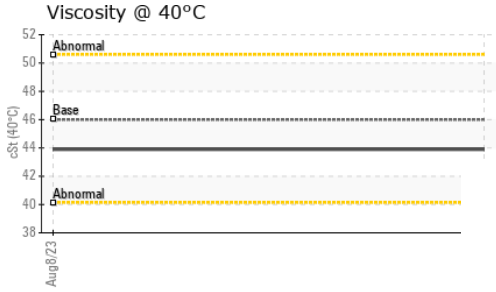
SAMPLE IMAGES	method	limit/base	current	history1	history2
---------------	--------	------------	---------	----------	----------

VISUAL	method	limit/base	current	history1	history2	
White Metal	scalar	*Visual	NONE	NONE	---	---
Yellow Metal	scalar	*Visual	NONE	NONE	---	---
Precipitate	scalar	*Visual	NONE	NONE	---	---
Silt	scalar	*Visual	NONE	▲ MODER	---	---
Debris	scalar	*Visual	NONE	▲ MODER	---	---
Sand/Dirt	scalar	*Visual	NONE	NONE	---	---
Appearance	scalar	*Visual	NORML	NORML	---	---
Odor	scalar	*Visual	NORML	NORML	---	---
Emulsified Water	scalar	*Visual	>0.05	▲ 0.2%	---	---
Free Water	scalar	*Visual		NEG	---	---

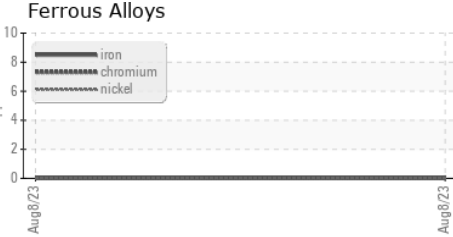
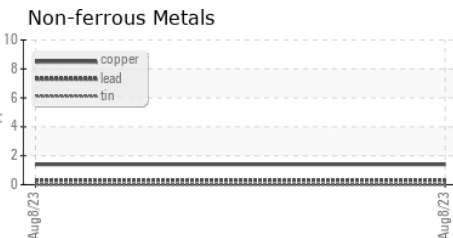
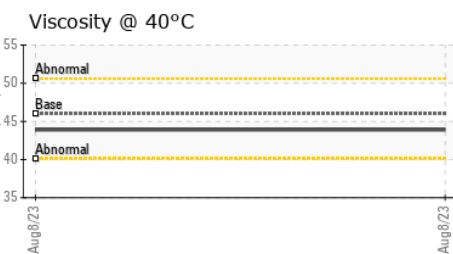
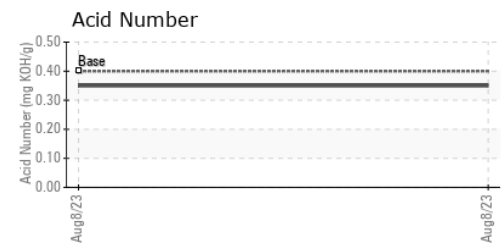
GRAPHS

CONTAMINANTS		method	limit/base	current	history1	history2
Silicon	ppm	ASTM D5185m	>25	0	---	---
Sodium	ppm	ASTM D5185m		5	---	---
Potassium	ppm	ASTM D5185m	>20	5	---	---
Water	%	ASTM D6304	>0.05	▲ 0.222	---	---
ppm Water	ppm	ASTM D6304	>500	▲ 2220	---	---
