Machine Id
GEM03 - 2

Component
Auxiliary Hydraulic System

Fluid
ROYAL PURPLE SYNFILM 22 (--- GAL)

OIL ANALYSIS REPORT

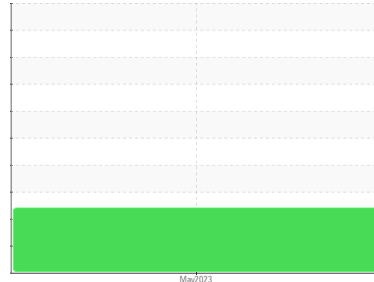
Sample Rating Trend

DIRT

▲ Silicon (ppm)

Sample Status				ABNORMAL	---	---
Silicon	ppm	ASTM D5185m	>20	▲ 48	---	---
Silt	scalar	*Visual	NONE	▲ MODER	---	---

We recommend you service the filters on this component. Resample at the next service interval to monitor. We were unable to perform a particle count due to a high concentration of particles present in this sample.

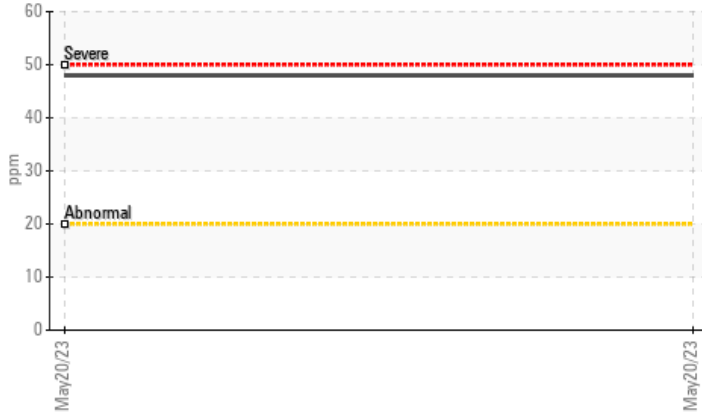
Elemental level of silicon (Si) above normal indicating ingress of seal material. There is a moderate amount of visible silt present in the sample.
