Area
Paper Machine
Machine Id
Vacuum Pump #3 Gearbox
Component
Gearbox
Fluid
MOBIL MOBILGEAR SHC 220 (55 GAL)

OIL ANALYSIS REPORT

Area
Paper Machine
 Machine Id
Vacuum Pump #3 Gearbox
 Component
Gearbox
 Fluid
MOBIL MOBILGEAR SHC 220 (55 GAL)

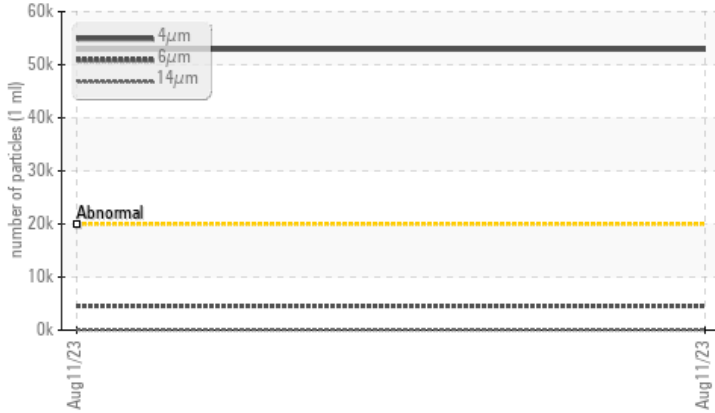
▲ Particle Trend

Sample Status			ABNORMAL	---	---
Particles >4µm	ASTM D7647	>20000	▲ 52881	---	---
Oil Cleanliness	ISO 4406 (c)	>21/19/16	▲ 23/19/14	---	---

Contamination
 There is a high amount of silt (particulates < 14 microns in size) present in the oil.

No corrective action is recommended at this time.
Resample at the next service interval to monitor.

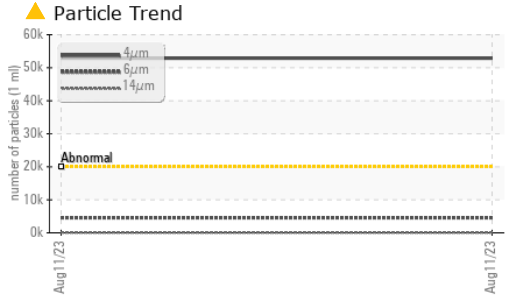
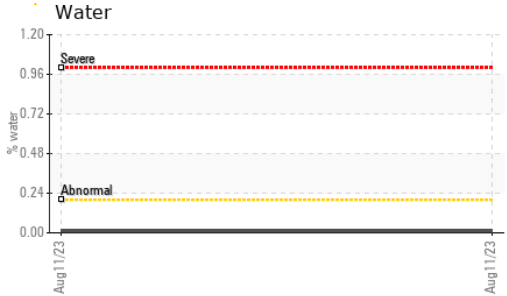
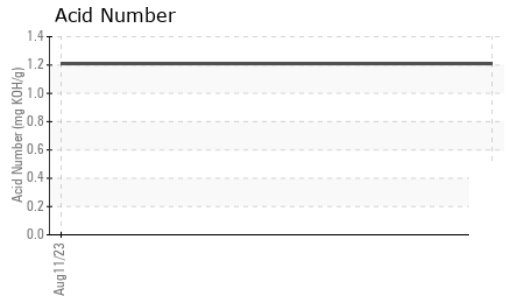
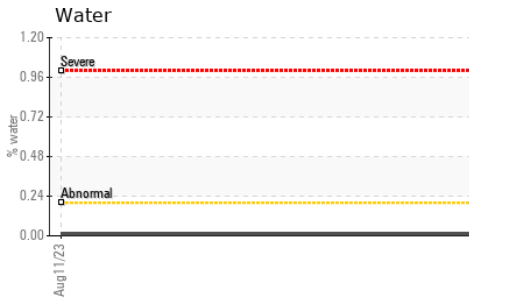
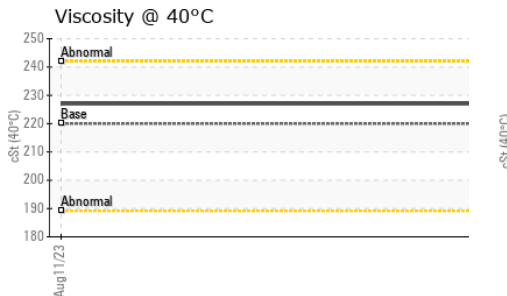
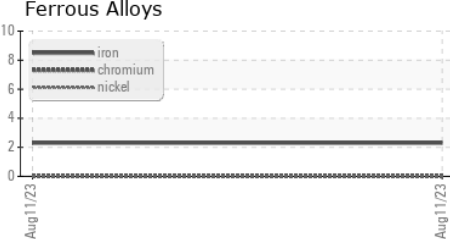
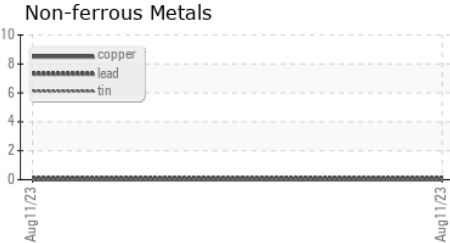
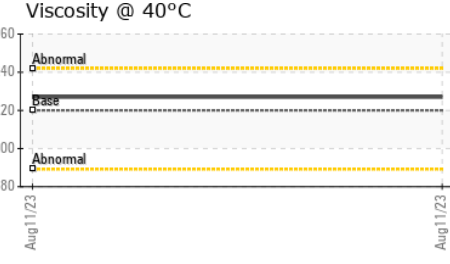
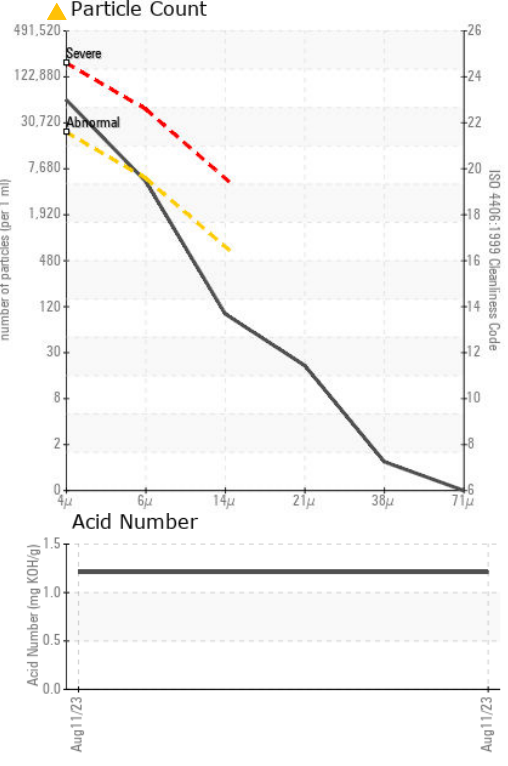
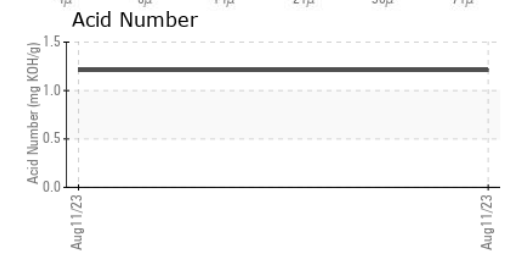
GRAPHS

method	limit/base	current	history1	history2
Particles >4µm ASTM D7647	>20000	▲ 52881	---	---
Particles >6µm ASTM D7647	>5000	4561	---	---
Particles >14µm ASTM D7647	>640	85	---	---
Particles >21µm ASTM D7647	>160	18	---	---
Particles >38µm ASTM D7647	>40	1	---	---
Particles >71µm ASTM D7647	>10	0	---	---
Oil Cleanliness ISO 4406 (c)	>21/19/16	▲ 23/19/14	---	---

Recommendation
 No corrective action is recommended at this time. Resample at the next service interval to monitor.
