# PROBLEM SUMMARY

Area  
**Paper Machine**  
 Machine Id  
**Vacuum Pump #6 Gearbox**  
 Component  
**Gearbox**  
 Fluid  
**MOBIL MOBILGEAR SHC 220 (35 GAL)**

# OIL ANALYSIS REPORT

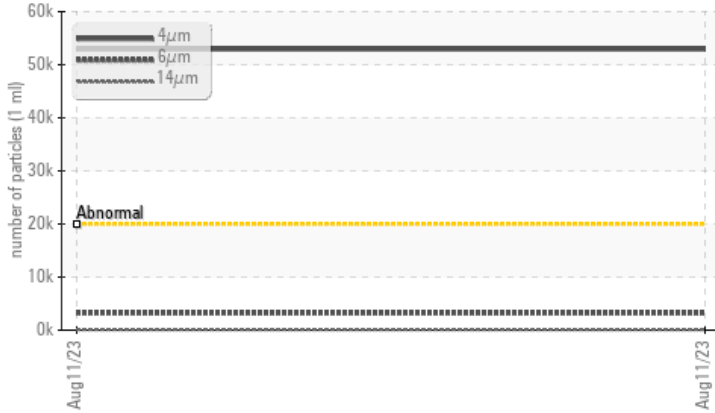
### ▲ Particle Trend

Sample Status			<b>ABNORMAL</b>	---	---
Particles >4µm	ASTM D7647	>20000	▲ 52918	---	---
Oil Cleanliness	ISO 4406 (c)	>21/19/16	▲ 23/19/14	---	---

There is a high amount of silt (particulates < 6 microns in size) present in the oil.

No corrective action is recommended at this time.  
 Resample at the next service interval to monitor.

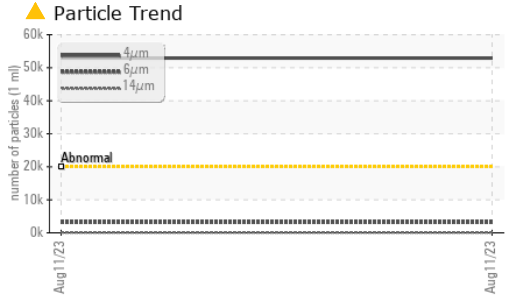
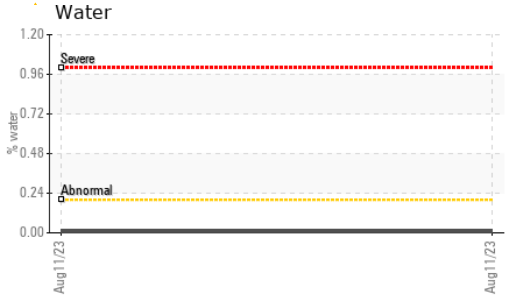
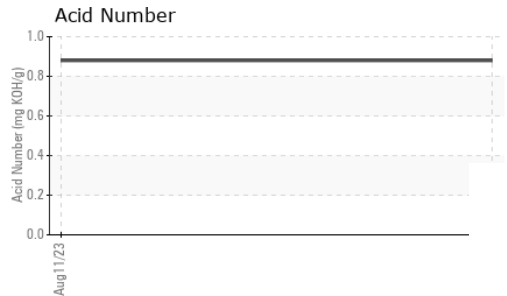
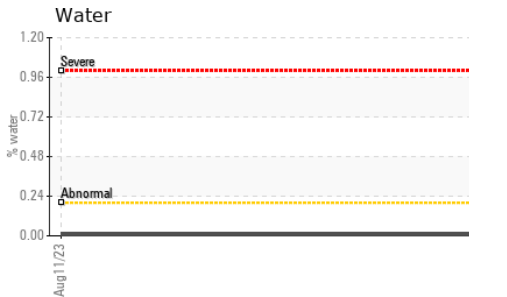
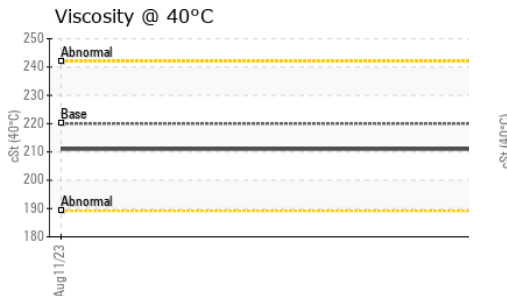
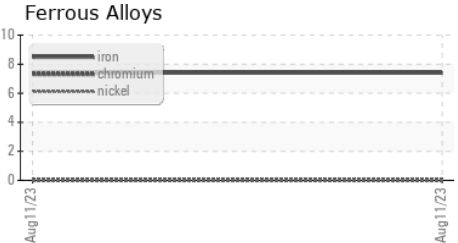
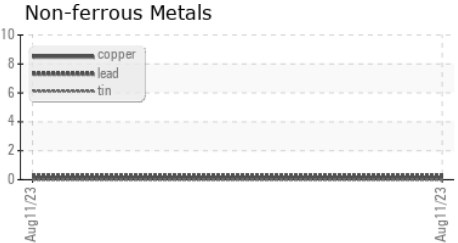
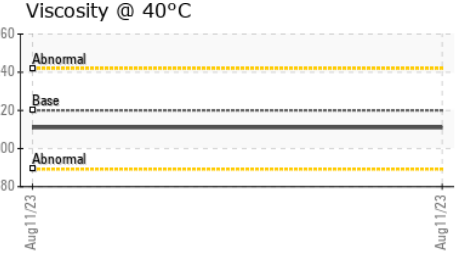
## GRAPHS

All component wear rates are normal.

The AN level is acceptable for this fluid. The condition of the oil is suitable for further service.

No corrective action is recommended at this time. Resample at the next service interval to monitor.
