# OIL ANALYSIS REPORT

Area  
**HIGHLAND [600380494]**  
 Machine Id  
**16WEA80823**  
 Component  
**Hydraulic System**  
 Fluid  
**SHELL TELLUS ARTIC 32 (--- LTR)**

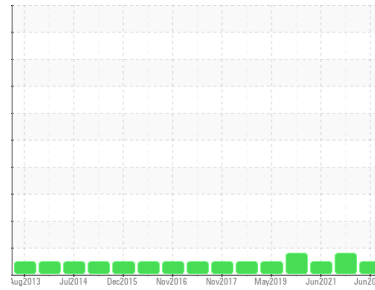
Sample Rating Trend

**NORMAL**

Resample at the next service interval to monitor.

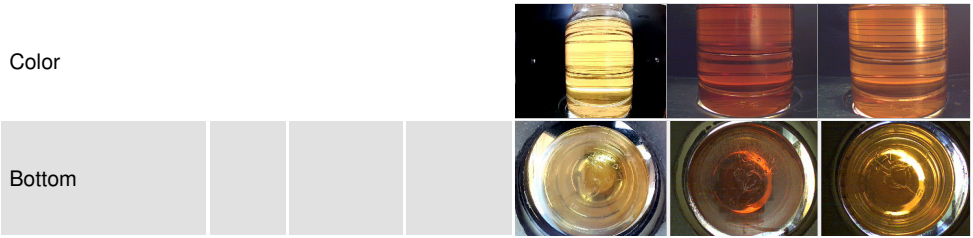
SAMPLE IMAGES		method	limit/base	current	history1	history2
---------------	--	--------	------------	---------	----------	----------

VISUAL		method	limit/base	current	history1	history2
White Metal	scalar	*Visual	NONE	<b>NONE</b>	NONE	NONE
Yellow Metal	scalar	*Visual	NONE	<b>NONE</b>	NONE	NONE
Precipitate	scalar	*Visual	NONE	<b>NONE</b>	NONE	NONE
Silt	scalar	*Visual	NONE	<b>NONE</b>	NONE	NONE
Debris	scalar	*Visual	NONE	<b>NONE</b>	NONE	NONE
Sand/Dirt	scalar	*Visual	NONE	<b>NONE</b>	NONE	NONE
Appearance	scalar	*Visual	NORML	<b>NORML</b>	NORML	NORML
Odor	scalar	*Visual	NORML	<b>NORML</b>	NORML	NORML
Emulsified Water	scalar	*Visual	>0.05	<b>NEG</b>	NEG	NEG
Free Water	scalar	*Visual		<b>NEG</b>	NEG	NEG
