# PROBLEM SUMMARY

Machine Id  
**5K9032.1AZBD**

Component  
**Gearbox**

Fluid  
**MOBIL GLYGOYLE 220 (--- GAL)**

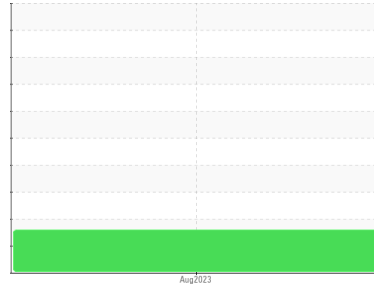
Sample Rating Trend

**WATER**

There is a moderate concentration of water present in the oil.

We advise that you check for the source of water entry. The oil change at the time of sampling has been noted. Resample at the next service interval to monitor.
