# FUEL REPORT

**JOHN DEERE 35G 1FF035GXLKK286676**

**Diesel Fuel**

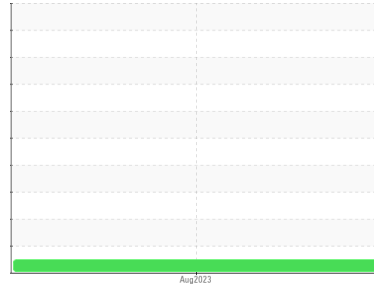
Sample Rating Trend

This is a baseline read-out on the submitted sample. No corrective action is recommended at this time.

All metal levels are normal indicating no corrosion in the system.

The water content is negligible. There is no indication of any contamination in the fuel.

The condition of the fuel is acceptable for the time in service.
