# PROBLEM SUMMARY

Area  
**Cochrane**  
 Machine Id  
**CCH01 Generator Thrust / Guide Bearing (S/N 2S57P485)**  
 Component  
**Case Drain Thrust Bearing**  
 Fluid  
**CONOCO MULTIPURPOSE R&O OIL ISO 68 (100 GAL)**

# OIL ANALYSIS REPORT

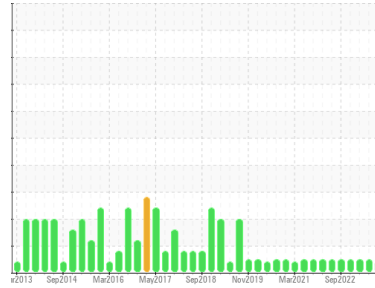
Sample Rating Trend

VIS DEBRIS

Sample Status				ABNORMAL	NORMAL	NORMAL
Debris	scalar	*Visual	NONE	▲ MODER	NONE	LIGHT

We recommend you service the filters on this component. Resample at the next service interval to monitor. We were unable to perform a particle count due to a high concentration of particles present in this sample.

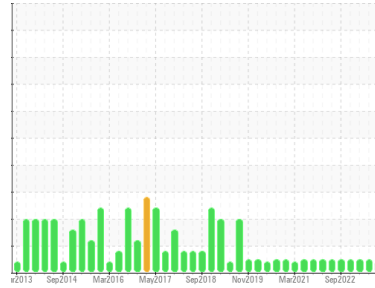
Sample Rating Trend

VIS DEBRIS

Moderate concentration of visible dirt/debris present in the oil.

We recommend you service the filters on this component. Resample at the next service interval to monitor. We were unable to perform a particle count due to a high concentration of particles present in this sample.

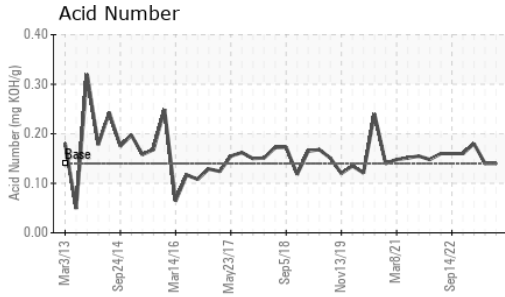
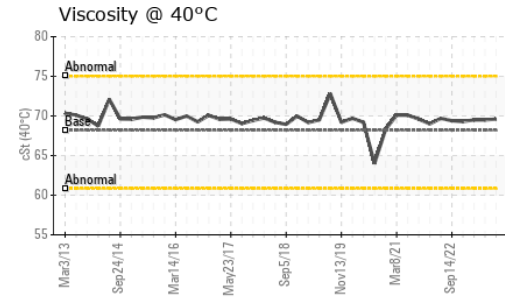
SAMPLE IMAGES	method	limit/base	current	history1	history2
---------------	--------	------------	---------	----------	----------

VISUAL	method	limit/base	current	history1	history2
White Metal	scalar	*Visual	NONE	NONE	NONE
Yellow Metal	scalar	*Visual	NONE	NONE	NONE
Precipitate	scalar	*Visual	NONE	NONE	NONE
Silt	scalar	*Visual	NONE	NONE	NONE
Debris	scalar	*Visual	▲ MODER	NONE	LIGHT
Sand/Dirt	scalar	*Visual	NONE	NONE	NONE
Appearance	scalar	*Visual	NORML	NORML	NORML
Odor	scalar	*Visual	NORML	NORML	NORML
Emulsified Water	scalar	*Visual	>2	NEG	NEG
Free Water	scalar	*Visual		NEG	NEG

Color			
Bottom			
PrtFilter	no image	no image	no image
