PROBLEM SUMMARY

Area
IRON STAR [200006142]
 Machine Id
58WEA88303
 Component
Wind Turbine Gearbox
 Fluid
GEAR OIL (PAO) ISO 320 (--- LTR)

OIL ANALYSIS REPORT

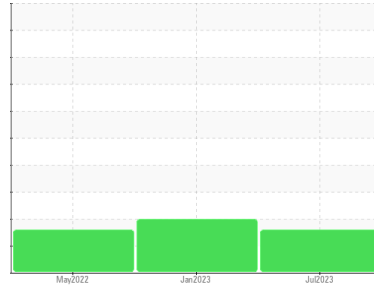
Sample Rating Trend

Sample Status			ABNORMAL	ABNORMAL	ABNORMAL
Particles >6µm	ASTM D7647	>320	▲ 7057	▲ 2612	▲ 884
Particles >14µm	ASTM D7647	>40	▲ 219	▲ 61	▲ 58
Particles >21µm	ASTM D7647	>10	▲ 33	▲ 15	▲ 21
Oil Cleanliness	ISO 4406 (c)	>--/15/12	▲ 23/20/15	▲ 23/19/13	▲ 22/17/13

We recommend you service the filters on this component if applicable. Resample at the next service interval to monitor.

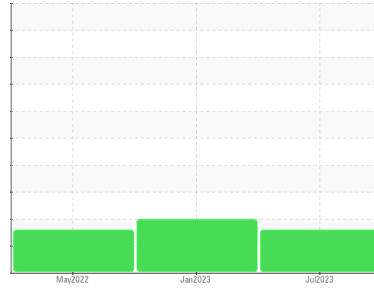
Sample Rating Trend

All component wear rates are normal.

There is a high amount of particulates present in the oil.

The AN level is acceptable for this fluid. The condition of the oil is suitable for further service.

We recommend you service the filters on this component if applicable. Resample at the next service interval to monitor.

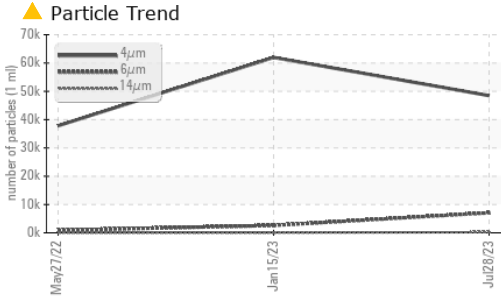
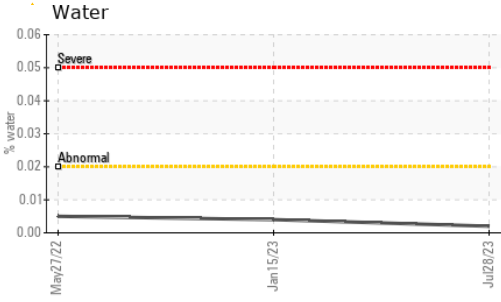
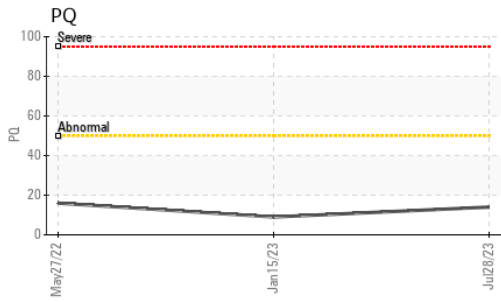
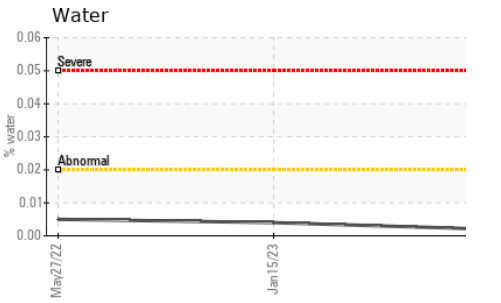
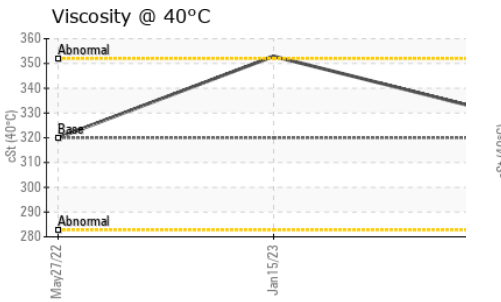
method	limit/base	current	history1	history2
Particles >4µm	ASTM D7647		48477	61968	37828
Particles >6µm	ASTM D7647	>320	▲ 7057	▲ 2612	▲ 884
Particles >14µm	ASTM D7647	>40	▲ 219	▲ 61	▲ 58
Particles >21µm	ASTM D7647	>10	▲ 33	▲ 15	▲ 21
Particles >38µm	ASTM D7647	>3	0	0	1
Particles >71µm	ASTM D7647	>3	0	0	0
Oil Cleanliness	ISO 4406 (c)	>--/15/12	▲ 23/20/15	▲ 23/19/13	▲ 22/17/13
