PROBLEM SUMMARY

Area
IRON STAR [200006142]
 Machine Id
61WEA88331
 Component
Wind Turbine Gearbox
 Fluid
GEAR OIL (PAO) ISO 320 (--- LTR)

OIL ANALYSIS REPORT

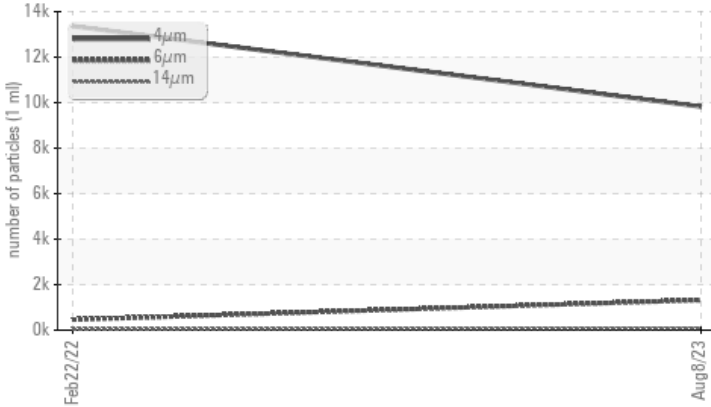
▲ Particle Trend

Sample Status			ATTENTION	NORMAL	---
Particles >6µm	ASTM D7647	>1300	▲ 1321	461	---
Oil Cleanliness	ISO 4406 (c)	>17/14	▲ 18/14	21/16/12	---

There is a moderate amount of silt (particulates < 14 microns in size) present in the oil.

No corrective action is recommended at this time.
 Resample at the next service interval to monitor.
