# PROBLEM SUMMARY

# OIL ANALYSIS REPORT

Machine Id  
**KAESER 7755050 (S/N 1080)**  
 Component  
**Compressor**  
 Fluid  
**KAESER SIGMA (OEM) S-460 (--- GAL)**

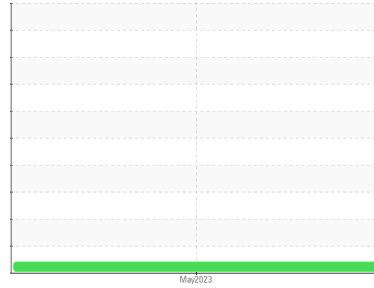
Sample Rating Trend

VIS DEBRIS

Sample Status				ABNORMAL	---	---
Debris	scalar	*Visual	NONE	▲ MODER	---	---

Oil and filter change at the time of sampling has been noted. No corrective action is recommended at this time. Resample at the next service interval to monitor. We were unable to perform a particle count due to a high concentration of particles present in this sample.

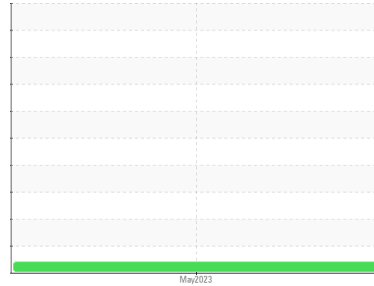
Sample Rating Trend

VIS DEBRIS

Moderate concentration of visible dirt/debris present in the oil.

Oil and filter change at the time of sampling has been noted. No corrective action is recommended at this time. Resample at the next service interval to monitor. We were unable to perform a particle count due to a high concentration of particles present in this sample.

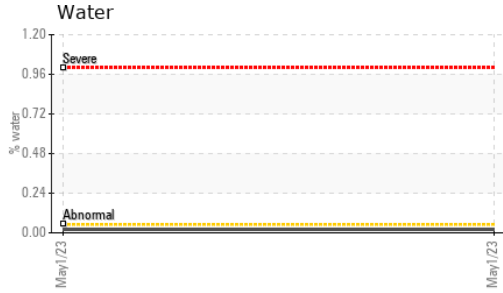
Color

VISUAL		method	limit/base	current	history1	history2
White Metal	scalar	*Visual	NONE	<b>NONE</b>	---	---
Yellow Metal	scalar	*Visual	NONE	<b>NONE</b>	---	---
Precipitate	scalar	*Visual	NONE	<b>NONE</b>	---	---
Silt	scalar	*Visual	NONE	<b>NONE</b>	---	---
Debris	scalar	*Visual	NONE	<b>▲ MODER</b>	---	---
Sand/Dirt	scalar	*Visual	NONE	<b>NONE</b>	---	---
Appearance	scalar	*Visual	NORML	<b>NORML</b>	---	---
Odor	scalar	*Visual	NORML	<b>NORML</b>	---	---
Emulsified Water	scalar	*Visual	>0.05	<b>NEG</b>	---	---
Free Water	scalar	*Visual		<b>NEG</b>	---	---

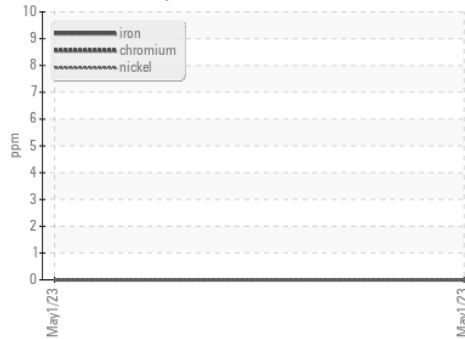
### Ferrous Alloys

All component wear rates are normal.

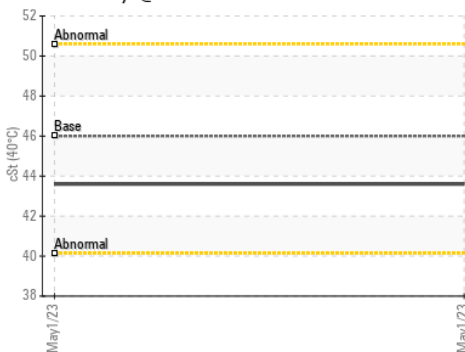
### Viscosity @ 40°C

FLUID PROPERTIES	method	limit/base	current	history1	history2
Visc @ 40°C	cSt	ASTM D445 46	43.6	---	---

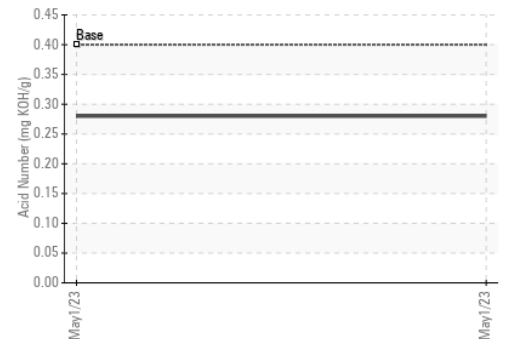
### Acid Number

The AN level is acceptable for this fluid. The condition of the oil is suitable for further service.

FLUID DEGRADATION		method	limit/base	current	history1	history2
Acid Number (AN)	mg KOH/g	ASTM D8045	0.4	<b>0.28</b>	---	---
