Machine Id
KAESER SK15 3675434 (S/N 1871)
 Component
Compressor
 Fluid
KAESER SIGMA (OEM) S-460 (--- GAL)

COMPONENT CONDITION SUMMARY

OIL ANALYSIS REPORT

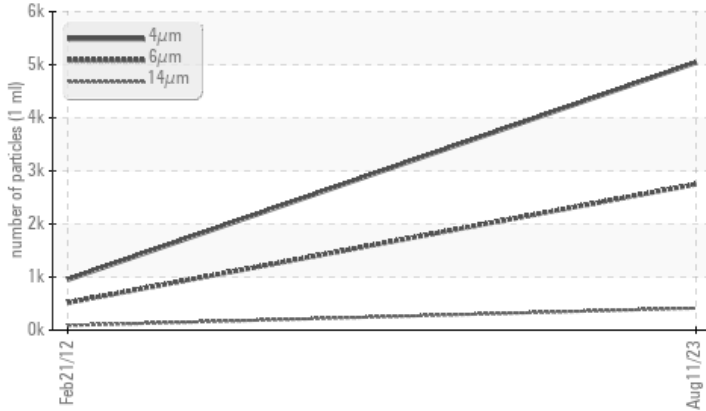
▲ Particle Trend

Sample Status			ABNORMAL	MARGINAL	---
Particles >6µm	ASTM D7647	>1300	▲ 2748	516	---
Particles >14µm	ASTM D7647	>80	▲ 415	▲ 88	---
Particles >21µm	ASTM D7647	>20	▲ 107	▲ 29	---
Particles >38µm	ASTM D7647	>4	▲ 5	▲ 4	---
Oil Cleanliness	ISO 4406 (c)	>--/17/13	▲ 20/19/16	▲ 16/14	---

We recommend you service the filters on this component. Resample at the next service interval to monitor.
