Machine Id
MHTF_B3 MHTF_B3_M3
Component
Drive End Bearing
Fluid
ROYAL PURPLE SYNFILM GT 32 (--- GAL)

Customer Id: ENEAST
Sample No.: RP0033062
Lab Number: 05935510
Test Package: IND 2

OIL ANALYSIS REPORT

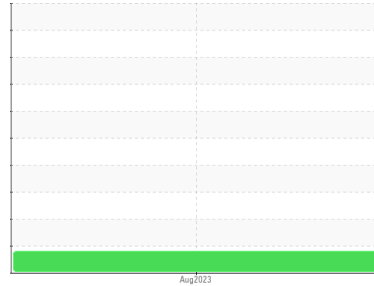
Sample Rating Trend

WEAR

▲ Non-ferrous Metals

Sample Status				ABNORMAL	---	---
Lead	ppm	ASTM D5185m	>20	▲ 29	---	---

No corrective action is recommended at this time.
Resample at the next service interval to monitor.

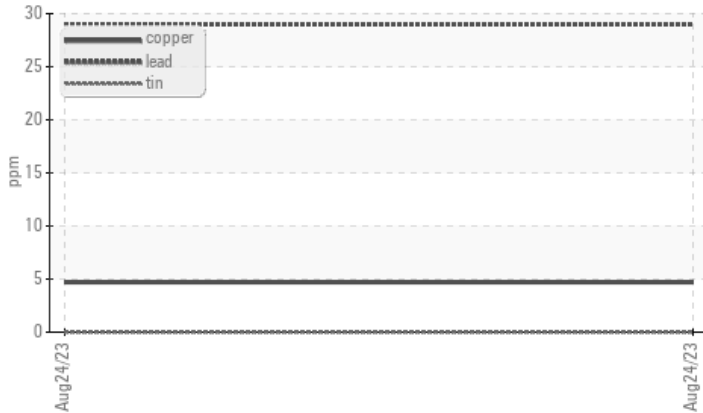
The lead level is abnormal. All other component wear rates are normal.

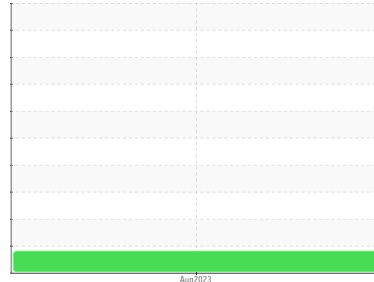
Sample Rating Trend

▲ **Wear**

There is no indication of any contamination in the oil.

The AN level is acceptable for this fluid. The condition of the oil is suitable for further service.

No corrective action is recommended at this time. Resample at the next service interval to monitor.
