OIL ANALYSIS REPORT

Machine Id
MHTF_P8 MHTF_P8_M8
 Component
Lube System
 Fluid
ROYAL PURPLE SYNFILM GT 46 (--- GAL)

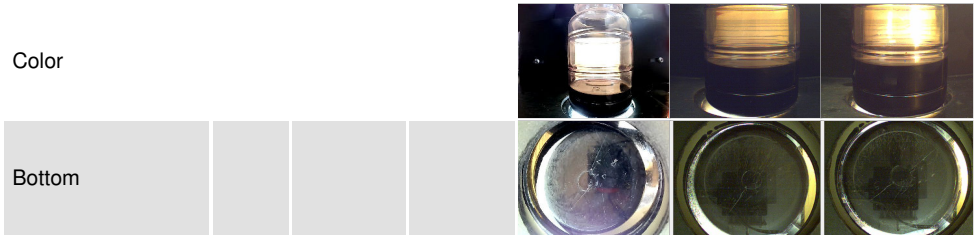
SAMPLE IMAGES	method	limit/base	current	history1	history2
---------------	--------	------------	---------	----------	----------

VISUAL	method	limit/base	current	history1	history2
White Metal	scalar	*Visual	NONE	NONE	NONE
Yellow Metal	scalar	*Visual	NONE	NONE	NONE
Precipitate	scalar	*Visual	NONE	NONE	NONE
Silt	scalar	*Visual	NONE	NONE	NONE
Debris	scalar	*Visual	NONE	NONE	LIGHT
Sand/Dirt	scalar	*Visual	NONE	NONE	NONE
Appearance	scalar	*Visual	NORML	NORML	NORML
Odor	scalar	*Visual	NORML	NORML	NORML
Emulsified Water	scalar	*Visual	>0.05	NEG	NEG
Free Water	scalar	*Visual		NEG	NEG

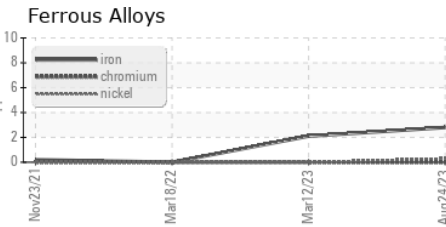
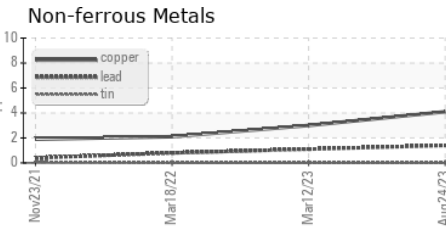
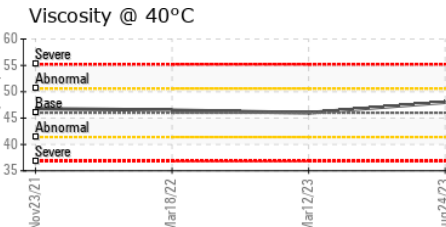
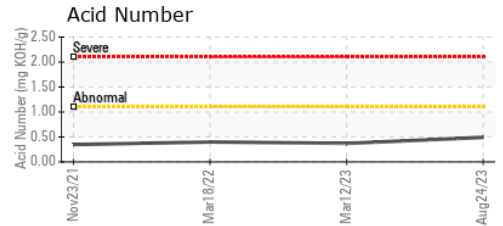
GRAPHS

All component wear rates are normal.

There is no indication of any contamination in the oil.

The AN level is acceptable for this fluid. The condition of the oil is suitable for further service.

Resample at the next service interval to monitor.
