OIL ANALYSIS REPORT

Area
HAPL
 Machine Id
HAPL EXIT ACCUMLATOR EAST
 Component
Gearbox
 Fluid
GEAR OIL ISO 150 (--- GAL)

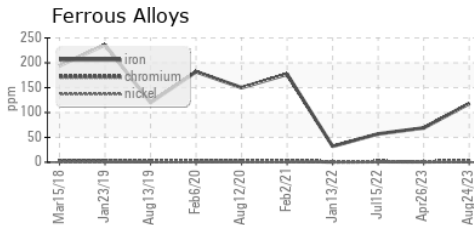
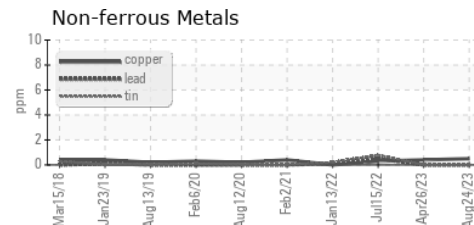
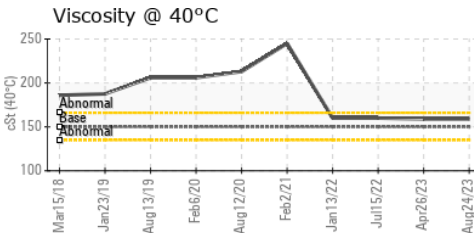
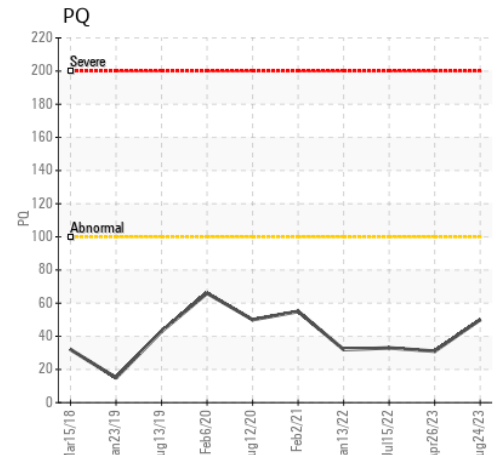
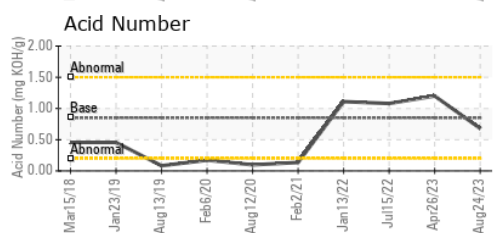
GRAPHS

All component wear rates are normal.

There is no indication of any contamination in the oil.

The AN level is acceptable for this fluid. The condition of the oil is suitable for further service.

Resample at the next service interval to monitor.
