OIL ANALYSIS REPORT

Area
OKLAHOMA/102/EG - SCRAPER
 Machine Id
76.31L [OKLAHOMA^102^EG - SCRAPER]
 Component
Front Left Final Drive
 Fluid
MOBIL MOBILUBE HD PLUS 85W140 (--- GAL)

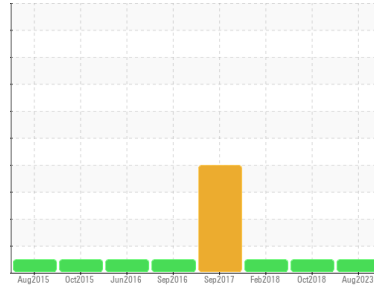
Sample Rating Trend

NORMAL

All component wear rates are normal.

There is no indication of any contamination in the oil.

The condition of the oil is acceptable for the time in service.

Resample at the next service interval to monitor.
