Machine Id
STARLINE SL-5250-4G 18 (S/N 05299)
 Component
Hydraulic System
 Fluid
NOT GIVEN (--- GAL)

Customer Id: NORTULOK
 Sample No.: PH0002003
 Lab Number: 05937654
 Test Package: PLANT

OIL ANALYSIS REPORT

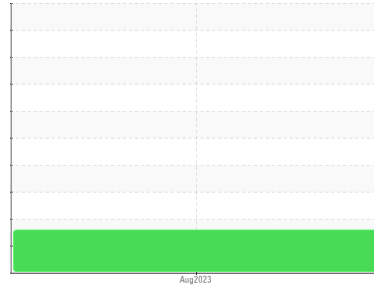
Sample Rating Trend

▲ Particle Trend

Sample Status				ABNORMAL	---	---
Particles >14µm	ASTM D7647	>320	▲ 694	---	---	
Particles >21µm	ASTM D7647	>80	▲ 385	---	---	
Particles >38µm	ASTM D7647	>20	▲ 62	---	---	
Oil Cleanliness	ISO 4406 (c)	>20/18/15	▲ 20/18/17	---	---	
PrtFilter				no image	no image

There is a high amount of particulates present in the oil.

We recommend you service the filters on this component. Resample at the next service interval to monitor. Please specify the brand, type, and viscosity of the oil on your next sample.

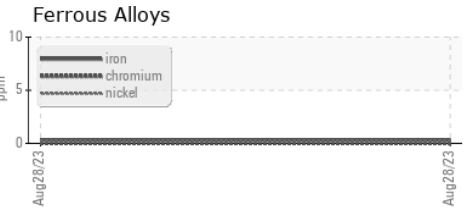
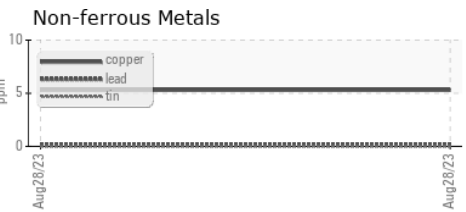
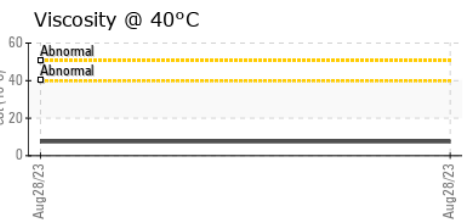
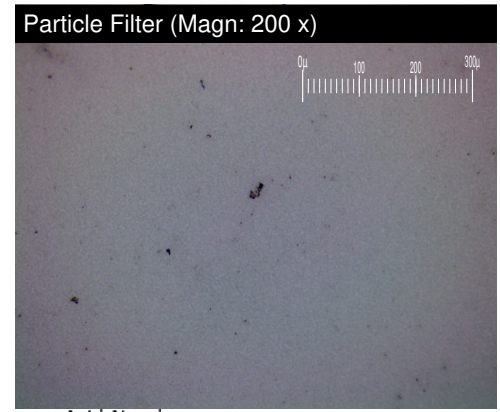
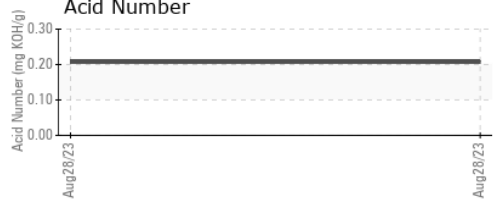
GRAPHS

FLUID CLEANLINESS		method	limit/base	current	history1	history2
Particles >4µm		ASTM D7647	>10000	7620	---	---
Particles >6µm		ASTM D7647	>2500	2343	---	---
Particles >14µm		ASTM D7647	>320	▲ 694	---	---
Particles >21µm		ASTM D7647	>80	▲ 385	---	---
Particles >38µm		ASTM D7647	>20	▲ 62	---	---
Particles >71µm		ASTM D7647	>4	4	---	---
Oil Cleanliness		ISO 4406 (c)	>20/18/15	▲ 20/18/17	---	---

We recommend you service the filters on this component. Resample at the next service interval to monitor. Please specify the brand, type, and viscosity of the oil on your next sample.
