Machine Id
30-69

Component
Hydraulic System

Fluid
CONOCO PHILLIPS GUARDOL ECT 15W40 (--- GAL)

OIL ANALYSIS REPORT

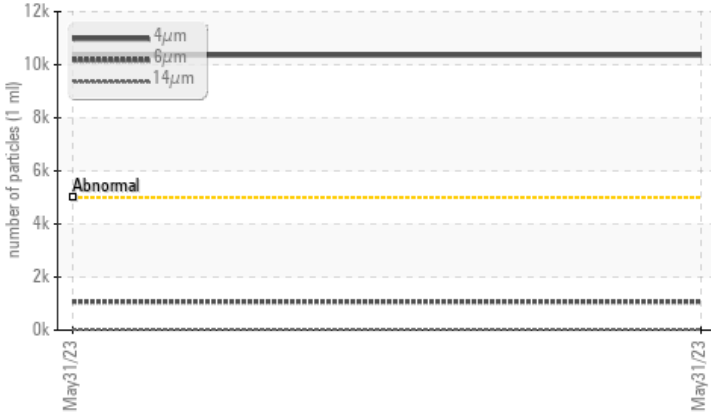
▲ Particle Trend

There is a high amount of silt (particulates < 6 microns in size) present in the oil.

No corrective action is recommended at this time.
Resample at the next service interval to monitor.
