PROBLEM SUMMARY

Machine Id
3802531 (S/N 1069)

Component
Compressor
Fluid
KAESER SIGMA (OEM) FG-460 (--- GAL)

OIL ANALYSIS REPORT

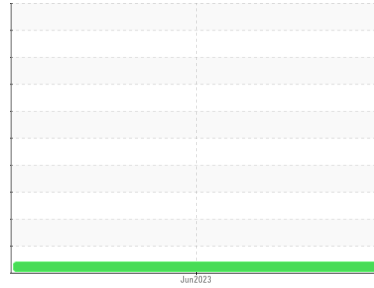
Sample Rating Trend

VIS DEBRIS

Moderate concentration of visible dirt/debris present in the oil.

We recommend you service the filters on this component. Resample at the next service interval to monitor. We were unable to perform a particle count due to a high concentration of particles present in this sample.

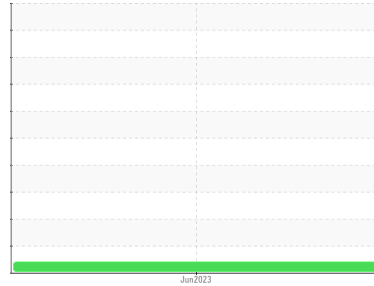
Sample Rating Trend

VIS DEBRIS

We recommend you service the filters on this component. Resample at the next service interval to monitor. We were unable to perform a particle count due to a high concentration of particles present in this sample.

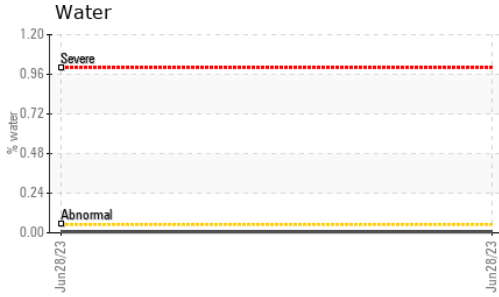
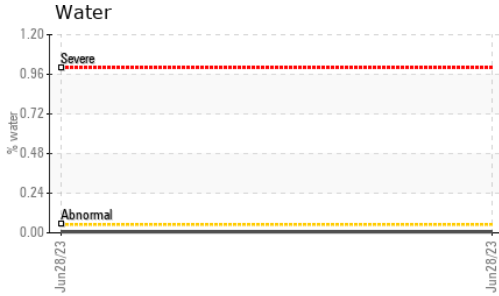
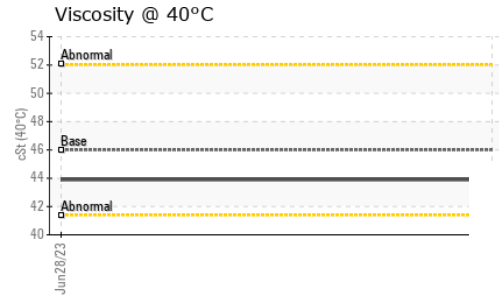
SAMPLE IMAGES

Sample Status				ABNORMAL	---	---
Debris	scalar	*Visual	NONE	▲ MODER	---	---

VISUAL	method	limit/base	current	history1	history2
White Metal	scalar	*Visual	NONE	NONE	---
Yellow Metal	scalar	*Visual	NONE	NONE	---
Precipitate	scalar	*Visual	NONE	NONE	---
Silt	scalar	*Visual	NONE	NONE	---
Debris	scalar	*Visual	NONE	▲ MODER	---
Sand/Dirt	scalar	*Visual	NONE	NONE	---
Appearance	scalar	*Visual	NORML	NORML	---
Odor	scalar	*Visual	NORML	NORML	---
Emulsified Water	scalar	*Visual	>0.05	NEG	---
Free Water	scalar	*Visual		NEG	---

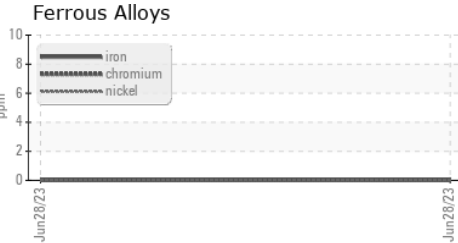
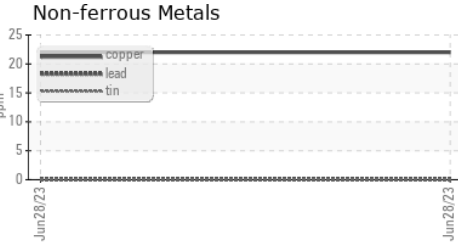
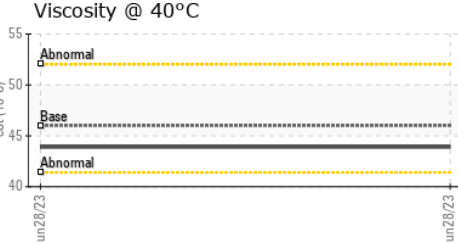
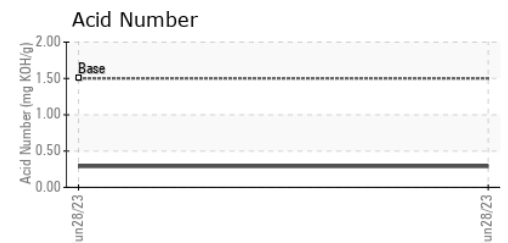
GRAPHS

FLUID PROPERTIES	method	limit/base	current	history1	history2
Visc @ 40°C	cSt	ASTM D445	46	43.9	---
