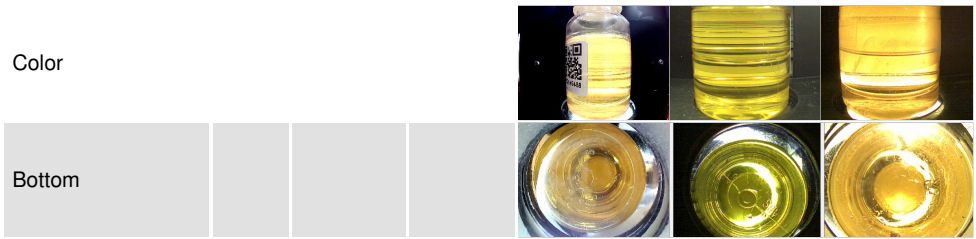
SAMPLE IMAGES	method	limit/base	current	history1	history2
---------------	--------	------------	---------	----------	----------

VISUAL	method	limit/base	current	history1	history2
White Metal	scalar	*Visual	NONE	NONE	NONE
Yellow Metal	scalar	*Visual	NONE	NONE	NONE
Precipitate	scalar	*Visual	NONE	NONE	NONE
Silt	scalar	*Visual	NONE	NONE	NONE
Debris	scalar	*Visual	NONE	NONE	NONE
Sand/Dirt	scalar	*Visual	NONE	NONE	NONE
Appearance	scalar	*Visual	NORML	NORML	NORML
Odor	scalar	*Visual	NORML	NORML	NORML
Emulsified Water	scalar	*Visual	>0.2	NEG	NEG
Free Water	scalar	*Visual		NEG	NEG

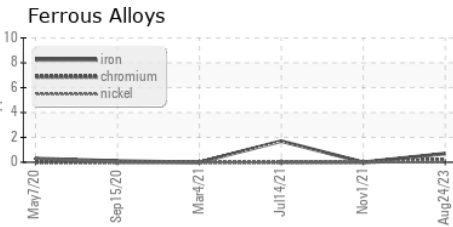
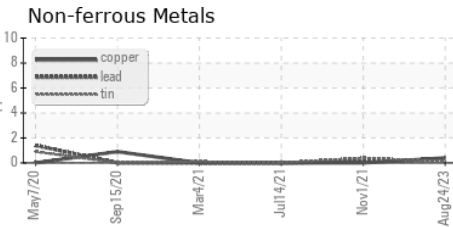
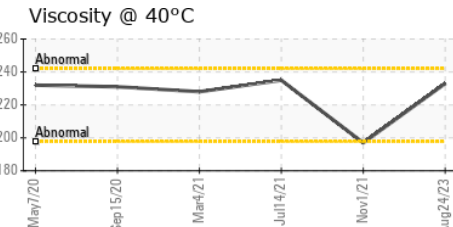
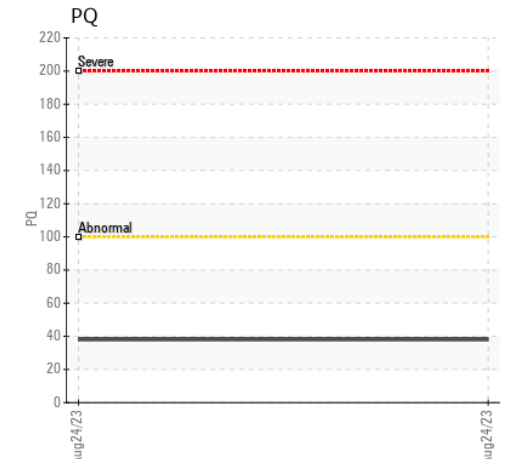
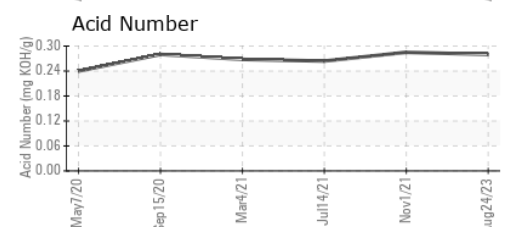
GRAPHS

All component wear rates are normal.

There is no indication of any contamination in the oil.

The AN level is acceptable for this fluid. The condition of the oil is suitable for further service.

Resample at the next service interval to monitor.
