Machine Id
49262091 (S/N 13336)
Component
Hydraulic System
Fluid
MOBIL DTE 24 (--- GAL)

Customer Id: TECGRENC
Sample No.: WC0844264
Lab Number: 05939036
Test Package: PLANT

OIL ANALYSIS REPORT

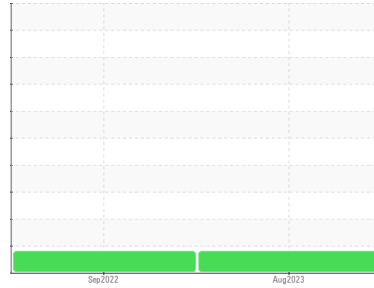
Sample Rating Trend

WEAR

▲ Non-ferrous Metals

RECOMMENDATION

No corrective action is recommended at this time.
Resample at the next service interval to monitor.

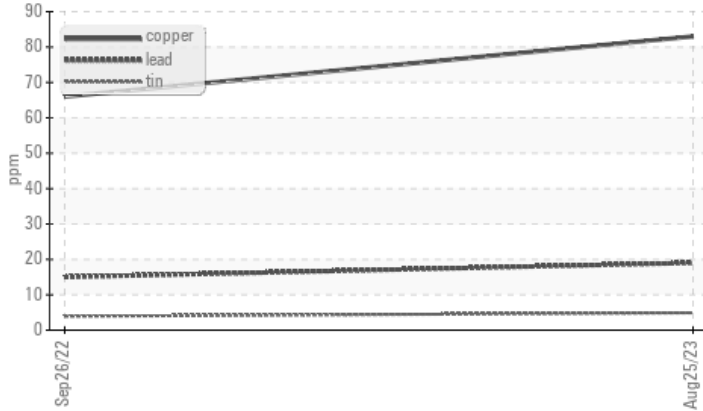
COMPONENT CONDITION SUMMARY

Sample Status				MARGINAL	ABNORMAL	---
Copper	ppm	ASTM D5185m	>200	▲ 83	▲ 66	---

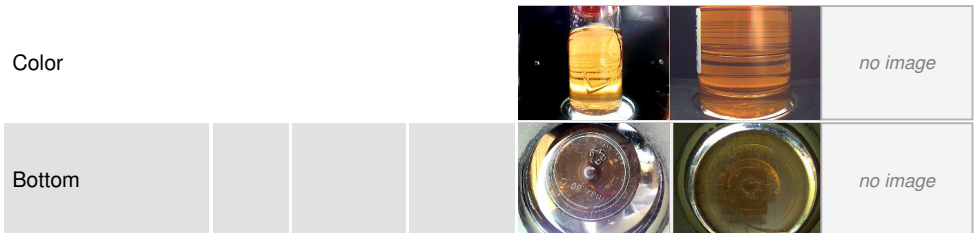
SAMPLE IMAGES

VISUAL	method	limit/base	current	history1	history2
White Metal	scalar	*Visual	NONE	NONE	---
Yellow Metal	scalar	*Visual	NONE	NONE	---
Precipitate	scalar	*Visual	NONE	NONE	---
Silt	scalar	*Visual	NONE	NONE	---
Debris	scalar	*Visual	NONE	NONE	---
Sand/Dirt	scalar	*Visual	NONE	NONE	---
Appearance	scalar	*Visual	NORML	NORML	---
Odor	scalar	*Visual	NORML	NORML	---
Emulsified Water	scalar	*Visual	>0.2	NEG	---
Free Water	scalar	*Visual		NEG	---
