Area
37534 (TRACE PO 36471) [37534]
 Machine Id
JP8TS0001-09182023C
 Component
Turbine
 Fluid
832020 JP8 MIL-DTL-83133 (--- LTR)

OIL ANALYSIS REPORT

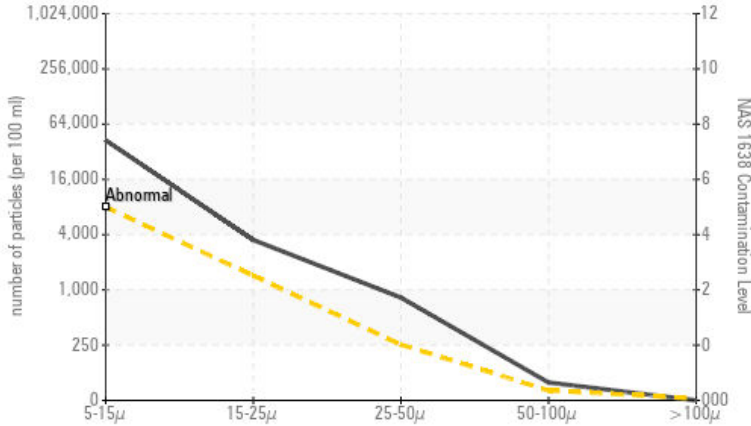
▲ Particle Count

Sample Status				ABNORMAL	---	---
Particles 5-15µm	count	*NAS 1638	>8000	▲ 42736	---	---
Particles 15-25µm	count	*NAS 1638	>1425	▲ 3502	---	---
Particles 25-50µm	count	*NAS 1638	>253	▲ 825	---	---
Particles 50-100µm	count	*NAS 1638	>45	▲ 81	---	---

There is a high amount of particulates present in the oil. The system cleanliness is above the acceptable limit for the target SAE AS4059 (replaces NAS 1638) cleanliness code.

We advise that you perform a filter service, and use off-line filtration to improve the cleanliness of the system fluid.
