# PROBLEM SUMMARY

Area  
**[140213]**  
 Machine Id  
**EISENBEISS EXT 4**  
 Component  
**Distribution Gear**  
 Fluid  
**MOBIL SHC 634 (--- GAL)**

# OIL ANALYSIS REPORT

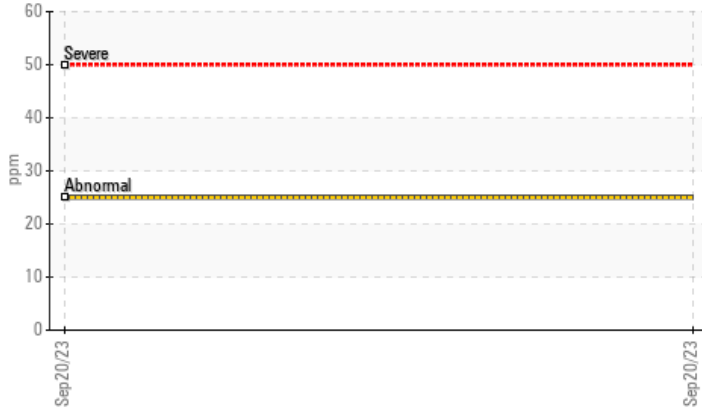
▲ Silicon (ppm)

Elemental level of silicon (Si) above normal.

CONTAMINANTS		method	limit/base	current	history1	history2
Silicon	ppm	ASTM D5185m	>25	<b>▲ 25</b>	---	---
Sodium	ppm	ASTM D5185m		<b>2</b>	---	---
Potassium	ppm	ASTM D5185m	>20	<b>0</b>	---	---

No corrective action is recommended at this time.  
 Resample at the next service interval to monitor.
