OIL ANALYSIS REPORT

Machine Id
KAESER ASD25T 6166591 (S/N 1126)

Component
Compressor
 Fluid
KAESER SIGMA (OEM) M-460 (6 GAL)

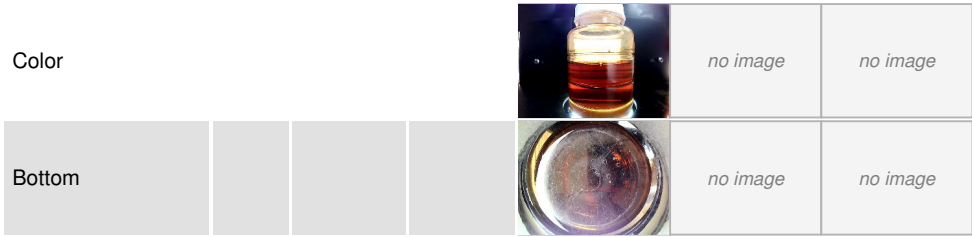
| SAMPLE IMAGES | method | limit/base | current | history1 | history2 |

| VISUAL | method | limit/base | current | history1 | history2 |
|---|---|---|---|---|---|
| White Metal | scalar | *Visual NONE | LIGHT | --- | --- |
| Appearance | scalar | *Visual NORML | NORML | --- | --- |
